# Access Compliance Report Public Rights-of-Way (Transit Stops)

| Intersection ID: 10036966 | Main Street: S_TRYON_ST | Cross Street: N/A | Location: S |
| ADA ID: CC477EA38A9C | Overall Compliance: No | Severity Score: 80 | |

CATS Stop ID: **46163**  
 CATS Stop Description: **Tryon St & Erwin Rd**  
 CATS Route ID: **16, 41x**  
 CATS Route Name: **Multiple**

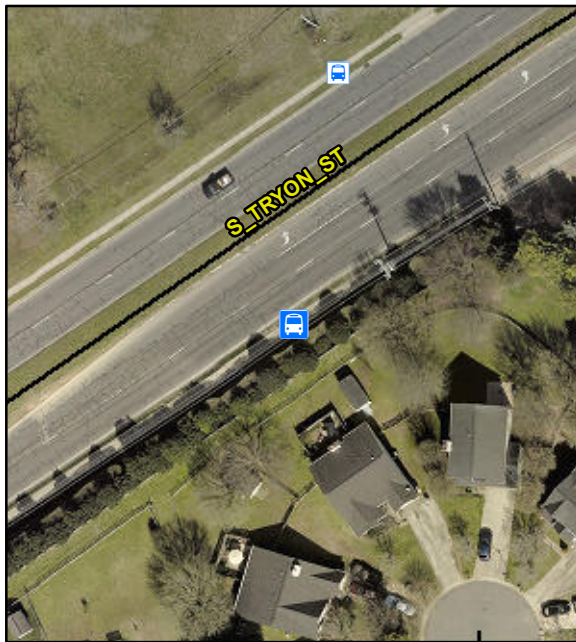
| Compliance | Description | Data |
|---|---|---|
| No | Boarding Area | No |
| No | Boarding Area Connected to PAR? | No |

**Provide Boarding Area. Provide Sidewalk Connection to Boarding Area.**
