# Access Compliance Report

## Public Rights-of-Way

### (Transit Stops)

| Intersection ID: 13644 | Main Street: BEECH_NUT_RD | Cross Street: WEST_BV | Location: N |

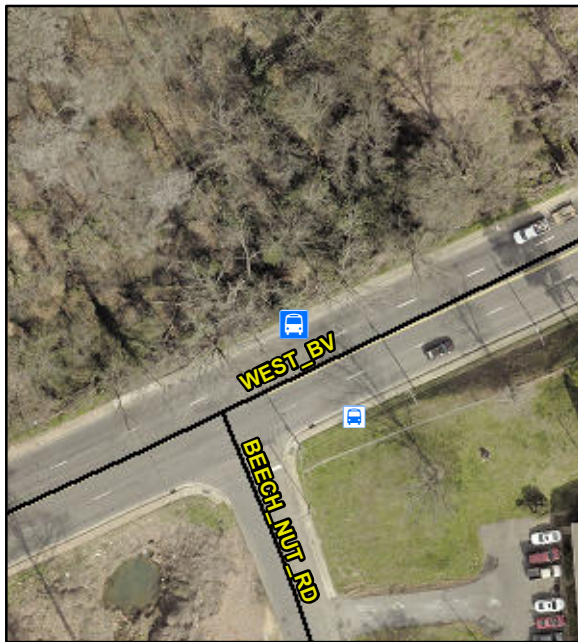
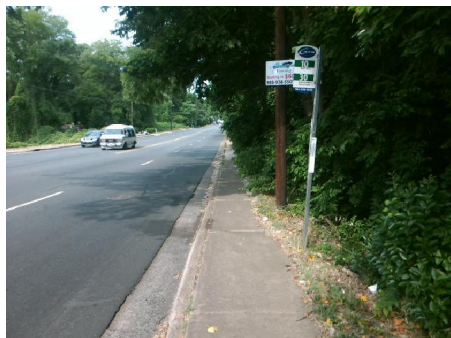
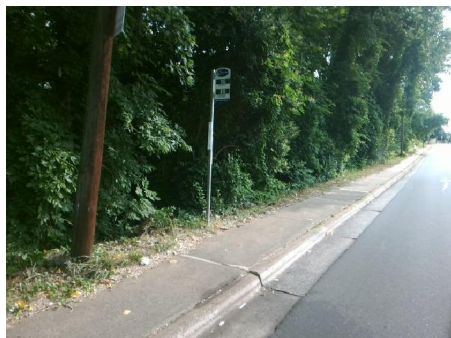
| Compliance | Description | Data |
|---|---|---|
| No | Boarding Area Width (in) | 54.0 |
| No | Boarding Area Length (in) | 54.0 |
| No | Boarding Area XSlope % | 3.1 |
| No | PAR 1 Width (in) | 47.0 |
| No | PAR 1 Slope % | 3.1 |
| No | PAR 2 Width (in) | 47.0 |
| No | PAR 2 XSlope % | 4.0 |

**Remove & Replace Boarding Area.  
Remove & Replace Sidewalk To  
Boarding Area.**
