# Access Compliance Report Public Rights-of-Way (Transit Stops)

| Intersection ID: 10016669 | Main Street: CINDY_LN | Cross Street: BALMAR_PLACE_RD | Location: N |
| ADA ID: CD2CB21A7C8D | Overall Compliance: No | Severity Score: 75 | |

CATS Stop Description: **Cindy Ln & Belmar Place Rd**

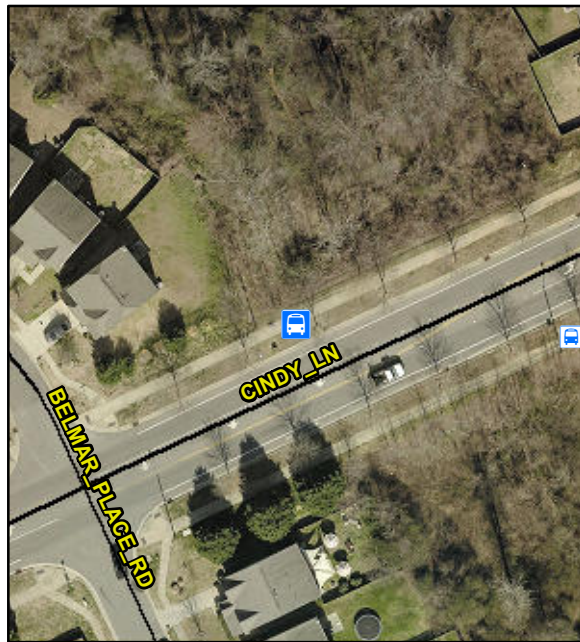
| Compliance | Description | Data |
|---|---|---|
| No | Boarding Area | No |
| No | PAR 1 Exist? | Yes |
| No | PAR 1 XSlope % | 2.6 |
| No | Boarding Area Connected to PAR? | No |

**Provide Boarding Area. Remove & Replace Sidewalk To Boarding Area. Provide Clear Floor Space. Remove or Relocate Protruding Objects/Obstructions.**

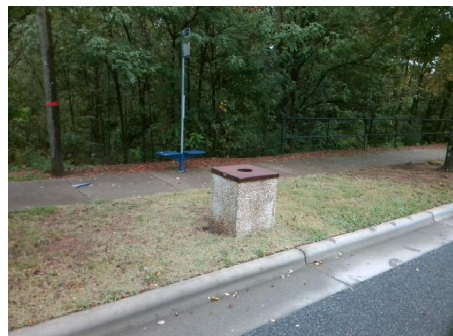
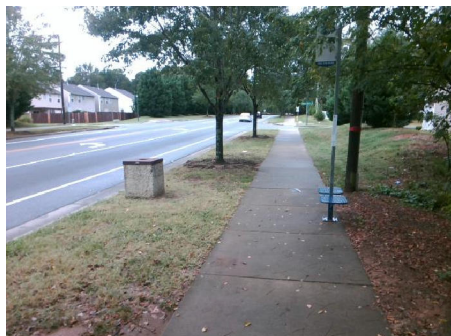
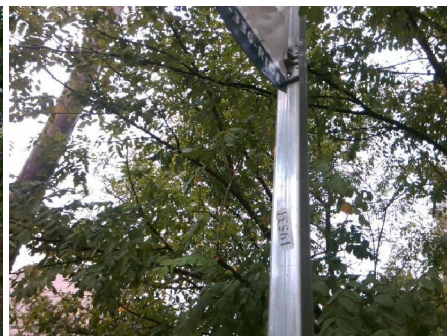
| Compliance | Description | Data |
|---|---|---|
| No | Clear Floor Space | No |
| No | Protruding Objects? | Yes |
