# Access Compliance Report Public Rights-of-Way (Transit Stops)

| Intersection ID: 10035443 | Main Street: RANDOLPH_RD | Cross Street: N/A | Location: NE |
| ADA ID: D8D9FC894F55 | Overall Compliance: No | Severity Score: 45 | |

CATS Stop Description: **Randolph Rd & Sardis Rd**

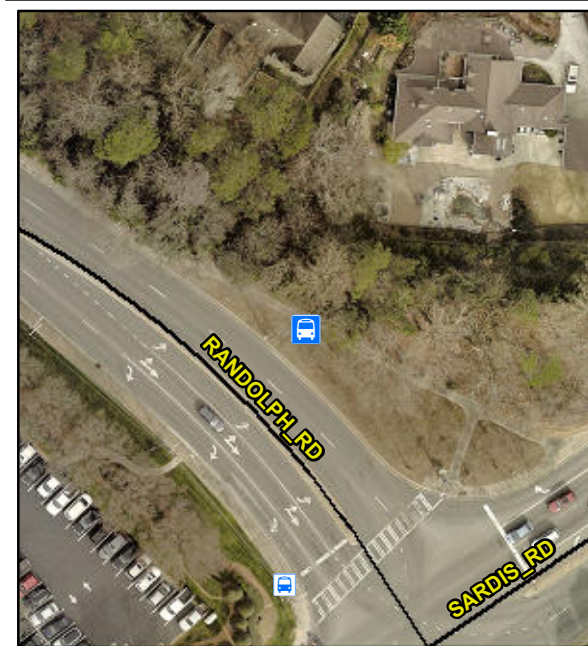
| Compliance | Description | Data |
|---|---|---|
| No | Boarding Area Width (in) | 45.0 |
| No | Boarding Area Slope % | 4.2 |
| No | Boarding Area XSlope % | 9.3 |

**Remove & Replace Boarding Area.  
Remove & Replace Sidewalk To  
Boarding Area. Remove & Replace  
Clear Floor Space.**

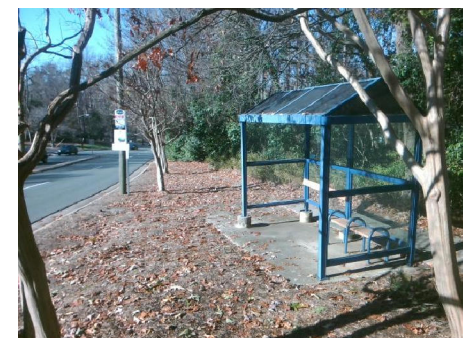
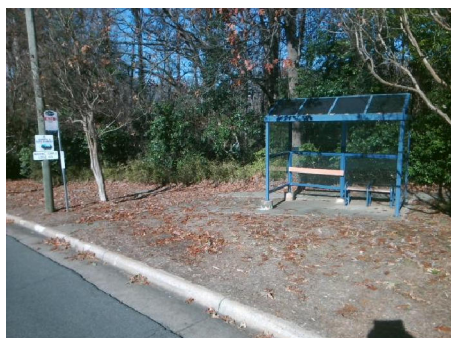
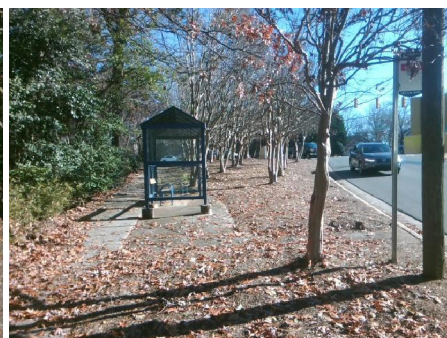
| Compliance | Description | Data |
|---|---|---|
| No | PAR 2 Exist? | Yes |
| No | PAR 2 XSlope % | 3.3 |
| No | Clear Floor Space | Yes |
| No | Clear Floor Space Slope % | 5.1 |
| No | Clear Floor Space XSlope % | 9.6 |
