# Access Compliance Report Public Rights-of-Way (Transit Stops)

| Intersection ID: 10033962 | Main Street: PARK_RD | Cross Street: N/A | Location: SE |
| ADA ID: DE3CF33EF1F3 | Overall Compliance: No | Severity Score: 15 | |

CATS Stop Description: Park Rd & Northampton Dr

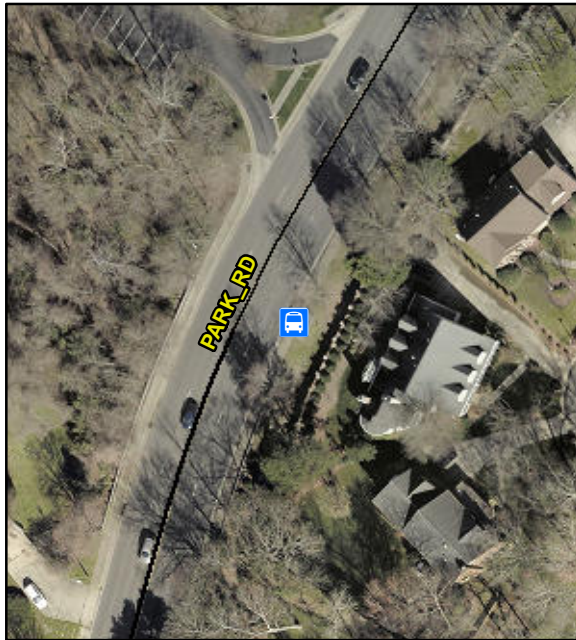
| Compliance | Description | Data |
|---|---|---|
| No | Boarding Area Length (in) | 82.0 |
| No | Boarding Area Slope % | 3.8 |
| No | PAR 1 XSlope % | 3.9 |
| No | PAR 2 XSlope % | 3.1 |
| No | Clear Floor Space | Yes |
| No | Clear Floor Space Slope % | 3.1 |
| No | Protruding Objects? | Yes |

Possible Solutions:

**Remove & Replace Boarding Area.  
Remove & Replace Sidewalk To  
Boarding Area. Remove & Replace  
Clear Floor Space. Remove or  
Relocate Protruding  
Objects/Obstructions.**
