# Access Compliance Report Public Rights-of-Way (Transit Stops)

| Intersection ID: 8312 | Main Street: HOVIS_RD | Cross Street: PONDEROSA_ST | Location: S |
| ADA ID: E8D9B61FF20C | Overall Compliance: No | Severity Score: 50 | |

CATS Stop Description: **Hovis Rd & Wildwood Ave**

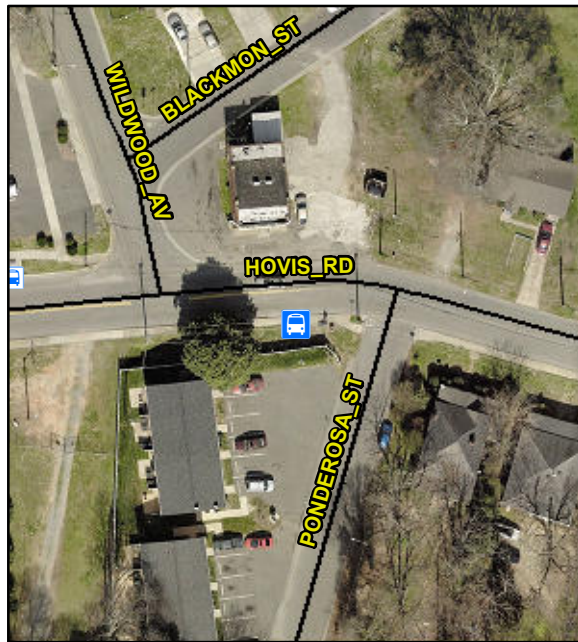
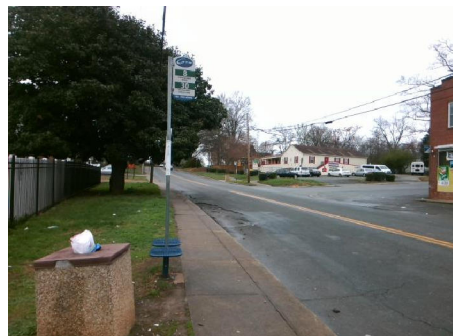
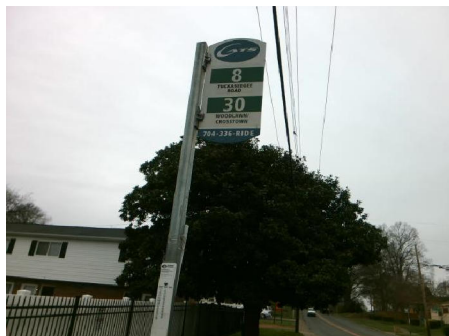
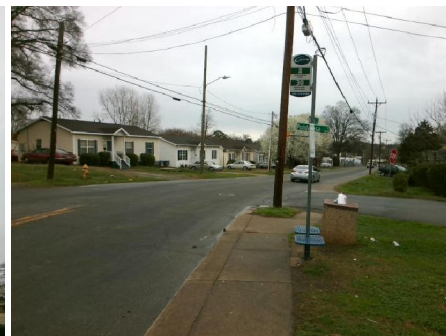
| Compliance | Description | Data |
|---|---|---|
| No | Boarding Area Length (in) | 50.0 |
| No | Boarding Area Slope % | 3.0 |
| No | Boarding Area XSlope % | 3.8 |
| No | PAR 1 Width (in) | 38.0 |
| No | PAR 1 Slope % | 3.8 |
| No | PAR 1 XSlope % | 3.0 |
| No | Clear Floor Space | No |
| No | Protruding Objects? | Yes |

**Remove & Replace Boarding Area.  
Remove & Replace Sidewalk To  
Boarding Area. Provide Clear Floor  
Space. Remove or Relocate  
Protruding Objects/Obstructions.**
