# Access Compliance Report Public Rights-of-Way (Transit Stops)

| Intersection ID: 10041329 | Main Street: WEST_BV | Cross Street: N/A | Location: S |
| ADA ID: F06A8AF13456 | Overall Compliance: No | Severity Score: 55 | |

CATS Stop Description: **West Blvd & Dr Carver Rd**

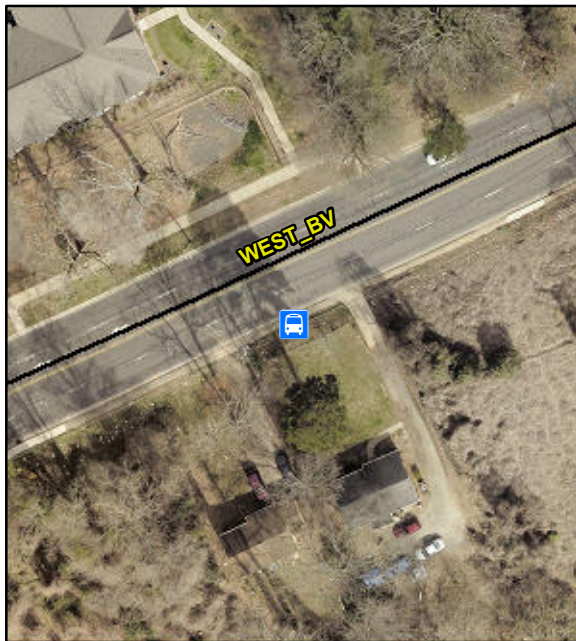
| Compliance | Description | Data |
|---|---|---|
| No | Boarding Area Width (in) | 48.0 |
| No | Boarding Area Length (in) | 60.0 |
| No | Boarding Area Slope % | 2.5 |
| No | PAR 1 Width (in) | 44.0 |
| No | PAR 1 XSlope % | 2.5 |
| No | PAR 2 Width (in) | 47.0 |
| No | PAR 2 XSlope % | 3.3 |
| No | Protruding Objects? | Yes |

**Remove & Replace Boarding Area.  
Remove & Replace Sidewalk To  
Boarding Area. Remove or Relocate  
Protruding Objects/Obstructions.**
