# Access Compliance Report Public Rights-of-Way (Transit Stops)

| Intersection ID: 10029234 | Main Street: JOHNSTON_RD | Cross Street: N/A | Location: NE |
| ADA ID: FA583680C394 | Overall Compliance: No | Severity Score: 80 | |

CATS Stop Description: **Johnston Rd & Carmel Rd**

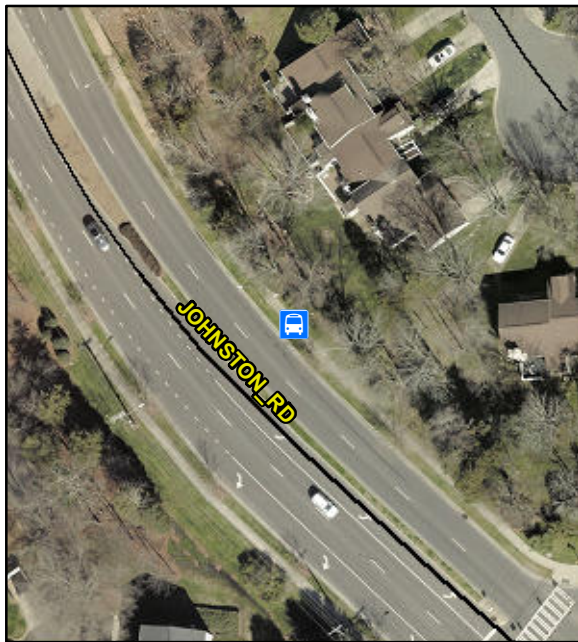
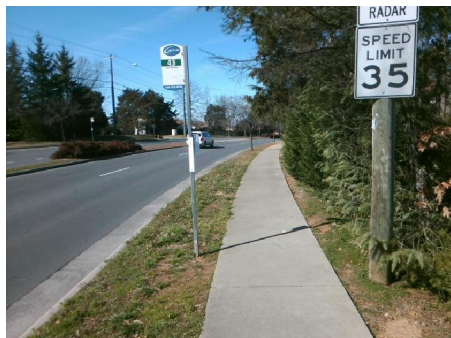
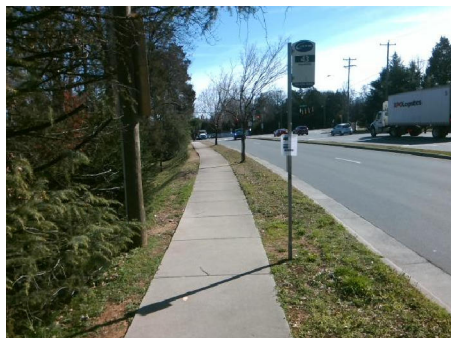
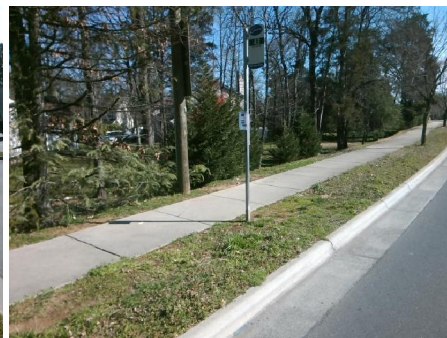
| Compliance | Description | Data |
|---|---|---|
| No | Boarding Area | No |
| No | PAR 1 Exist? | Yes |
| No | PAR 1 XSlope % | 2.1 |
| No | Boarding Area Connected to PAR? | No |

**Provide Boarding Area. Remove & Replace Sidewalk To Boarding Area.**
