# Access Compliance Report

## Public Rights-of-Way

### (Accessible Street Parking)

Intersection ID: N/A	Main Street: ISOM ST	Location: N/A
ADA ID: B96115CC028D	ParkingType: ParaPark	Overall Compliance: No
		Severity Score: 0.0
Codes/Mitigation Info/Possible Solution		Field Measurements/Component Compliance

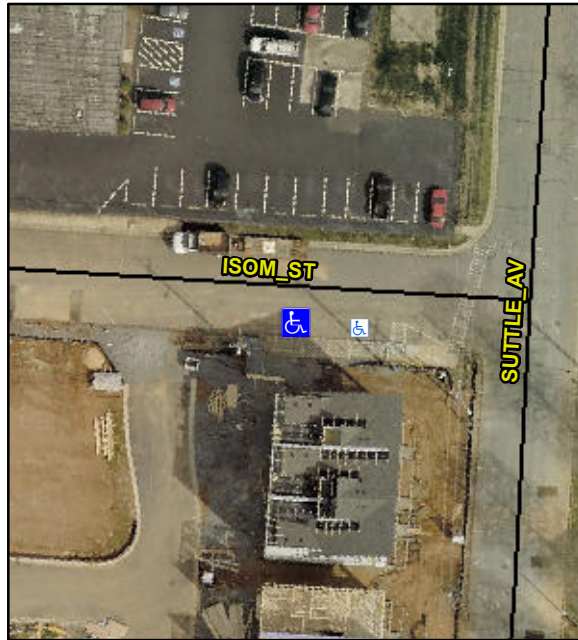
Compliance	Description	Data	Compliance	Description	Data
N/A	Parking Spot At End of Block?	Yes	Yes	Accessible Route?	Yes
No	Adjacent Sidewalk Width (in)	N/A	No	Access Aisle Marking?	Yes
No	Adjacent Sidewalk Slope (%)	N/A	Yes	Access Aisle Width (in)	93.0
No	Adjacent Sidewalk XSlope (%)	N/A	No	Access Aisle Length (in)	342.0
No	Adjacent Sidewalk Clear of Obstr.	No	N/A	Access Aisle Location	Side
	N/A	Parking Spot Width (in)		102.0	
	N/A	Parking Spot Length (in)		269.0	
	N/A	Van Accessible?		N/A	
	No	Curb Ramp?		No	
	N/A	Identification Sign?		N/A	
	N/A	Sign Height (in)		N/A	
	N/A	Vertical Clearance		N/A	
	N/A	Parking Meter?		N/A	
	N/A	Parking Meter Height (in)		N/A	
	N/A	Meter Operable Parts?		N/A	
	N/A	Meter Clear Space?		N/A	
	N/A	Meter Clear Space Slope (%)		N/A	
	N/A	Meter Clear Space XSlope (%)		N/A	
	N/A	Meter Forward Reach?		N/A	
	N/A	Meter Forward Reach (in)		N/A	
	N/A	Meter Parallel Reach?		N/A	
	N/A	Meter Parallel Reach (in)		N/A

N/A	Parking Space/Access Aisle Slopes (%)						
C Slope (%)	1.4	D Slope (%)	1.0	I Slope (%)	N/A	L Slope (%)	N/A
B Slope (%)	2.1	E Slope (%)	1.7	H Slope (%)	N/A	K Slope (%)	N/A
A Slope (%)	1.6	F Slope (%)	1.0	G Slope (%)	N/A	J Slope (%)	N/A
N/A	Parking Space/Access Aisle XSlopes (%)						
C XSlope (%)	1.3	D XSlope (%)	3.1	I XSlope (%)	N/A	L XSlope (%)	N/A
B XSlope (%)	2.7	E XSlope (%)	4.8	H XSlope (%)	N/A	K XSlope (%)	N/A
A XSlope (%)	2.8	F XSlope (%)	3.1	G XSlope (%)	N/A	J XSlope (%)	N/A

**Advise relocating to an area with maximum 2% slopes**
