Access Compliance Report
Public Rights-of-Way
(Curb Ramps)

Intersection ID: 6021 | **Main Street:** GIBBON_RD | **Cross Street:** PLUM_ST | **Location:** NW

ADA ID: 021CCD33D03B | **Ramp Type:** Directional1 | **Initial Pass/Fail:** Fail | **Overall Compliance:** No | **Severity Score:** 1.25

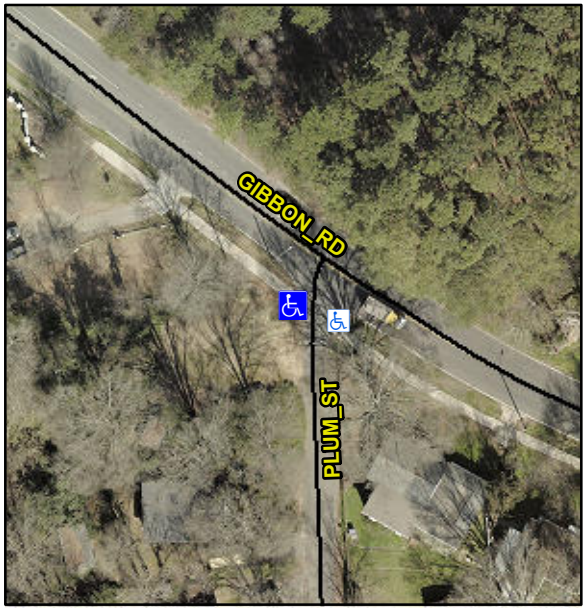
NO CURB. RP SL < 5%

R304.5.3

Remove & Replace Entire Ramp.
