# Access Compliance Report
# Public Rights-of-Way
# (Curb Ramps)

| Intersection ID: 8650 | Main Street: GARNETTE_PL | Cross Street: ST_MARK_ST | Location: | NW |
| ADA ID: 049A06A70653 | Ramp Type: BlendTrans2 | Initial Pass/Fail: Fail | Overall Compliance: No | Severity Score: 21.25 |

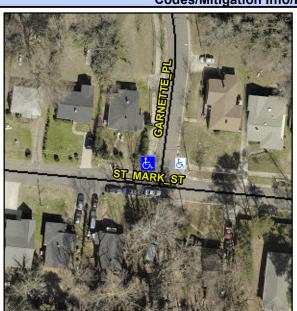
**VEGETATION OVERGROWTH, NO LT SW**

**Not Found,  R304.5.1, R304.5.3**

| Compliance | Description | Data | Compliance | Description | Data |
|---|---|---|---|---|---|
| No | Ramp Width (in) | 44.0 | No | BlendTrans XSlope (%) | 5.9 |
| | | | No | Curb Slope (%) | 18.8 |

**Remove & Replace Curb Ramp With Two New Directional Ramps or Equivalent.**
