Access Compliance Report

# Public Rights-of-Way
(Curb Ramps)

Intersection ID: 11865	Main Street: SEABROOK_DR	Cross Street: WEYLAND_AV	Location:	SE
ADA ID: 055FEAD8B1D4	Ramp Type: PerpDiag	Initial Pass/Fail: Fail	Overall Compliance: No	Severity Score: 22.5

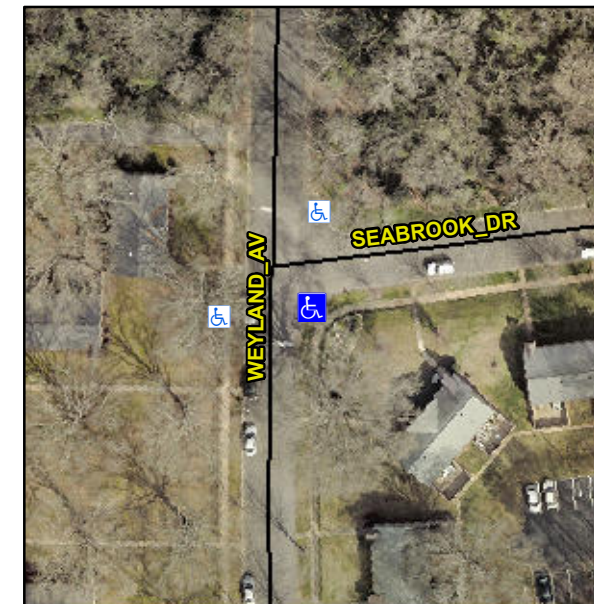
Not Found, R304.5.1, R304.2.2, R304.5.3

Compliance	Description	Data	Compliance	Description	Data
N/A	Ramp Length (in)	72.0	No	Ramp Slope (%)	11.1
No	Ramp Width (in)	45.0	No	Ramp XSlope (%)	3.6
N/A	Flare Type LT	N/A	N/A	Flare Type RT	N/A
N/A	Flare Slope LT (%)	N/A	N/A	Flare Slope RT (%)	N/A
N/A	Flare Traversable LT?	N/A	N/A	Flare Traversable RT?	N/A
N/A	Landing Length (in)	N/A	N/A	DWS Provided?	N/A
N/A	Landing Width (in)	N/A	N/A	DWS Contrast?	N/A
N/A	Landing Slope (%)	N/A	N/A	DWS Length (in)	N/A
N/A	Landing X Slope (%)	N/A	N/A	DWS Full Width?	N/A
N/A	Landing Curb? (Y/N)	N/A	N/A	DWS Offset (in)	N/A
N/A	Shared Landing?	N/A			
N/A	Gutter Ponding?	N/A	N/A	Gutter Slope (%)	N/A
N/A	Gutter Lip Ht (in)	N/A	N/A	Gutter X Slope (%)	N/A
N/A	Painted X Walk1?	No	N/A	Painted X Walk2?	No
	X Walk 1 Direction	To N		X Walk 2 Direction	To W
N/A	X Walk 1 Width (in)	N/A	N/A	X Walk 2 Width (in)	N/A
	X Walk 1 Slope (%)	3.1		X Walk 2 Slope (%)	5.4
	X Walk 1 X Slope (%)	1.7		X Walk 2 X Slope (%)	3.1

Remove & Replace Curb Ramp With Two New Directional Ramps or Equivalent.
