Access Compliance Report
Public Rights-of-Way
(Curb Ramps)

Intersection ID: 32274	Main Street: MYERS_MILL_LN	Cross Street: WILLOUGHBY_RUN_DR	Location: E
ADA ID: 05C44D32BAD2	Ramp Type: PerpDiag	Initial Pass/Fail: Fail	Overall Compliance: No	Severity Score: 21.25

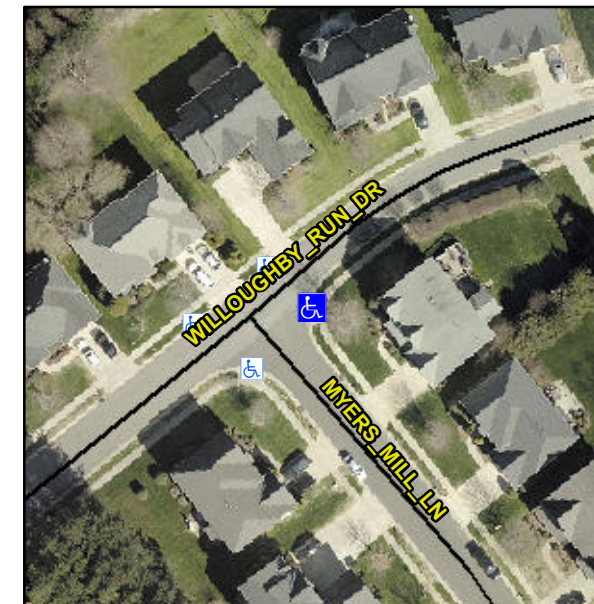
Not Found, R304.5.1, R304.2.2

Compliance	Description	Data	Compliance	Description	Data
N/A	Ramp Length (in)	45.0	No	Ramp Slope (%)	10.0
No	Ramp Width (in)	41.0	Yes	Ramp XSlope (%)	0.2
N/A	Flare Type LT	N/A	N/A	Flare Type RT	N/A
N/A	Flare Slope LT (%)	N/A	N/A	Flare Slope RT (%)	N/A
N/A	Flare Traversable LT?	N/A	N/A	Flare Traversable RT?	N/A
N/A	Landing Length (in)	N/A	N/A	DWS Provided?	N/A
N/A	Landing Width (in)	N/A	N/A	DWS Contrast?	N/A
N/A	Landing Slope (%)	N/A	N/A	DWS Length (in)	N/A
N/A	Landing X Slope (%)	N/A	N/A	DWS Full Width?	N/A
N/A	Landing Curb? (Y/N)	N/A	N/A	DWS Offset (in)	N/A
N/A	Shared Landing?	N/A			
N/A	Gutter Ponding?	N/A	N/A	Gutter Slope (%)	N/A
N/A	Gutter Lip Ht (in)	N/A	N/A	Gutter X Slope (%)	N/A
N/A	Painted X Walk1?	No	N/A	Painted X Walk2?	No
	X Walk 1 Direction	To NW		X Walk 2 Direction	To SW
N/A	X Walk 1 Width (in)	N/A	N/A	X Walk 2 Width (in)	N/A
	X Walk 1 Slope (%)	0.3		X Walk 2 Slope (%)	0.4
	X Walk 1 X Slope (%)	0.9		X Walk 2 X Slope (%)	0.3

Remove & Replace Curb Ramp With Two New Directional Ramps or Equivalent.
