# Access Compliance Report
Public Rights-of-Way
(Curb Ramps)

Intersection ID: 10031995	Main Street: MONROE_RD	Cross Street: N/A		Location:	SW
ADA ID: 05D164C8AAFC	Ramp Type: PerpDiag	Initial Pass/Fail: Fail	Overall Compliance: No	Severity Score:	26.25

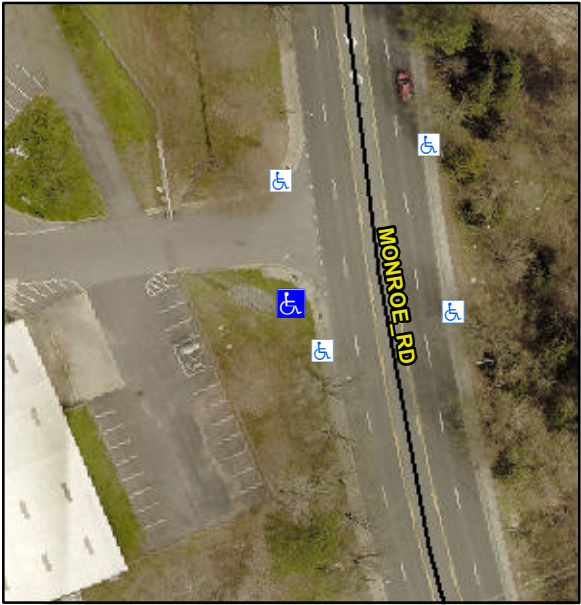
Not Found, R304.2.2, R304.5.3

Compliance	Description	Data	Compliance	Description	Data
N/A	Ramp Length (in)	69.0	No	Ramp Slope (%)	14.0
Yes	Ramp Width (in)	48.0	No	Ramp XSlope (%)	2.7
N/A	Flare Type LT	N/A	N/A	Flare Type RT	N/A
N/A	Flare Slope LT (%)	N/A	N/A	Flare Slope RT (%)	N/A
N/A	Flare Traversable LT?	N/A	N/A	Flare Traversable RT?	N/A
N/A	Landing Length (in)	N/A	N/A	DWS Provided?	N/A
N/A	Landing Width (in)	N/A	N/A	DWS Contrast?	N/A
N/A	Landing Slope (%)	N/A	N/A	DWS Length (in)	N/A
N/A	Landing X Slope (%)	N/A	N/A	DWS Full Width?	N/A
N/A	Landing Curb? (Y/N)	N/A	N/A	DWS Offset (in)	N/A
N/A	Shared Landing?	N/A			
N/A	Gutter Ponding?	N/A	N/A	Gutter Slope (%)	N/A
N/A	Gutter Lip Ht (in)	N/A	N/A	Gutter X Slope (%)	N/A
N/A	Painted X Walk1?	No	N/A	Painted X Walk2?	No
	X Walk 1 Direction	To E		X Walk 2 Direction	To N
N/A	X Walk 1 Width (in)	N/A	N/A	X Walk 2 Width (in)	N/A
	X Walk 1 Slope (%)	0.9		X Walk 2 Slope (%)	2.5
	X Walk 1 X Slope (%)	0.8		X Walk 2 X Slope (%)	0.3

Remove & Replace Curb Ramp With Two New Directional Ramps or Equivalent.
