# Access Compliance Report
Public Rights-of-Way
(Curb Ramps)

Intersection ID: 10033082   **Main Street:** NORTH_REA_PARK_LN   **Cross Street:** N/A   **Location:** S

ADA ID: 0604428A44F4   **Ramp Type:** Perp   **Initial Pass/Fail:** Fail   **Overall Compliance:** No   **Severity Score:** 12.5

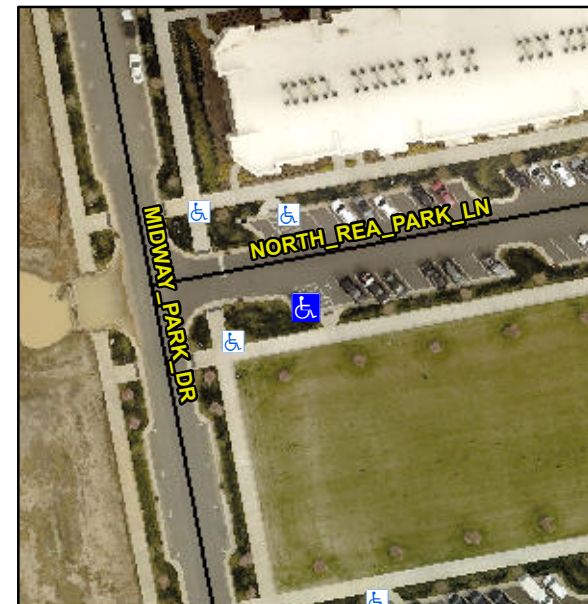
Not Found, R304.2.2

Compliance	Description	Data	Compliance	Description	Data
N/A	Ramp Length (in)	95.0	No	Ramp Slope (%)	8.7
Yes	Ramp Width (in)	59.5	Yes	Ramp XSlope (%)	0.2
N/A	Flare Type LT	N/A	N/A	Flare Type RT	N/A
N/A	Flare Slope LT (%)	N/A	N/A	Flare Slope RT (%)	N/A
N/A	Flare Traversable LT?	N/A	N/A	Flare Traversable RT?	N/A
N/A	Landing Length (in)	N/A	N/A	DWS Provided?	N/A
N/A	Landing Width (in)	N/A	N/A	DWS Contrast?	N/A
N/A	Landing Slope (%)	N/A	N/A	DWS Length (in)	N/A
N/A	Landing X Slope (%)	N/A	N/A	DWS Full Width?	N/A
N/A	Landing Curb? (Y/N)	N/A	N/A	DWS Offset (in)	N/A
N/A	Shared Landing?	N/A			
N/A	Gutter Ponding?	N/A	N/A	Gutter Slope (%)	N/A
N/A	Gutter Lip Ht (in)	N/A	N/A	Gutter X Slope (%)	N/A
N/A	Painted X Walk1?	No	N/A	Painted X Walk2?	N/A
	X Walk 1 Direction	To N		X Walk 2 Direction	N/A
N/A	X Walk 1 Width (in)	N/A	N/A	X Walk 2 Width (in)	N/A
	X Walk 1 Slope (%)	3.6		X Walk 2 Slope (%)	N/A
	X Walk 1 X Slope (%)	1.7		X Walk 2 X Slope (%)	N/A

Remove & Replace Entire Ramp.
