Access Compliance Report
Public Rights-of-Way
(Curb Ramps)

Intersection ID: 10020377 **Main Street:** BALLANTYNE_CORPORATE_PL **Cross Street:** N/A **Location:** SE

ADA ID: 060E8E1F9FF0 **Ramp Type:** BlendTrans1 **Initial Pass/Fail:** Fail **Overall Compliance:** No **Severity Score:** 25

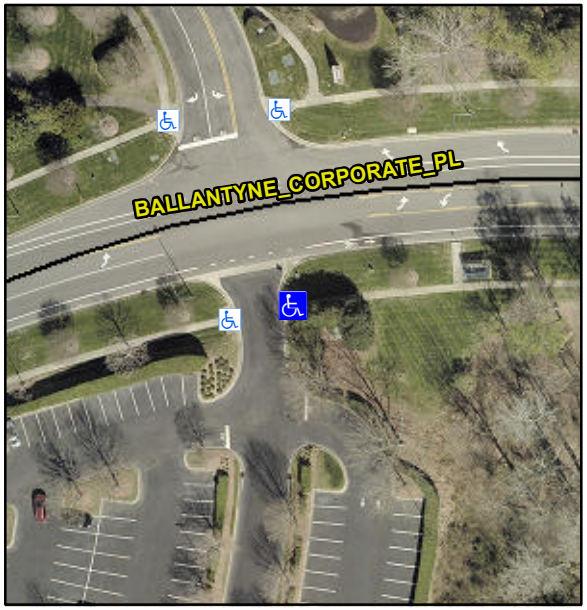
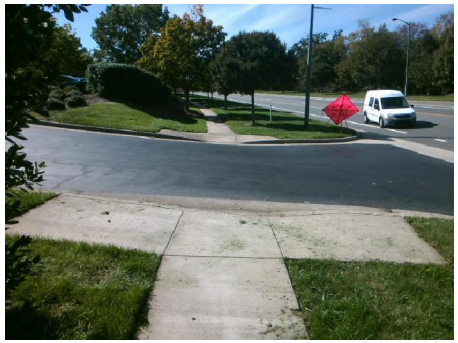
R304.5.3

Compliance	Description	Data	Compliance	Description	Data
N/A	Ramp Length (in)	60.0	Yes	BlendTrans Slope (%)	4.5
Yes	Ramp Width (in)	48.0	No	BlendTrans XSlope (%)	8.1
N/A	Flare Type LT	N/A	N/A	Flare Type RT	N/A
N/A	Flare Slope LT (%)	N/A	N/A	Flare Slope RT (%)	N/A
N/A	Flare Traversable LT?	N/A	N/A	Flare Traversable RT?	N/A
N/A	Landing Length (in)	N/A	N/A	DWS Provided?	N/A
N/A	Landing Width (in)	N/A	N/A	DWS Contrast?	N/A
N/A	Landing Slope (%)	N/A	N/A	DWS Length (in)	N/A
N/A	Landing X Slope (%)	N/A	N/A	DWS Full Width?	N/A
N/A	Landing Curb? (Y/N)	N/A	N/A	DWS Offset (in)	N/A
N/A	Shared Landing?	N/A			
N/A	Gutter Ponding?	N/A	N/A	Gutter Slope (%)	N/A
N/A	Gutter Lip Ht (in)	N/A	N/A	Gutter X Slope (%)	N/A
N/A	Painted X Walk1?	No	N/A	Painted X Walk2?	N/A
	X Walk 1 Direction	To SW		X Walk 2 Direction	N/A
	X Walk 1 Width (in)	N/A		X Walk 2 Width (in)	N/A
	X Walk 1 Slope (%)	1.5		X Walk 2 Slope (%)	N/A

Remove & Replace Curb Ramp With Two New Directional Ramps or Equivalent.
