Access Compliance Report
Public Rights-of-Way
(Curb Ramps)

Intersection ID: 5833 **Main Street:** GUM_BRANCH_RD **Cross Street:** KENTBERRY_DR **Location:** N

ADA ID: 061EF9660034 **Ramp Type:** BlendTrans1 **Initial Pass/Fail:** Fail **Overall Compliance:** No **Severity Score:** 8.75

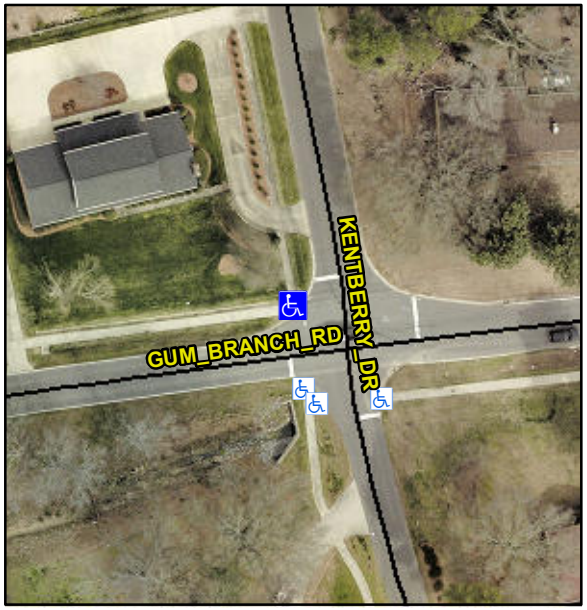
GTR GAP 1.0

Not Found, R304.5.1

N/A	Ramp inside XWalk1?	N/A	N/A	Ramp inside XWalk2?	N/A
	Road Slope (%)	2.7		Clear Space?	N/A
	Road X Slope (%)	0.0	N/A	Clear Space to XWalk (in)	N/A
N/A	Any Obstructions?	N/A	N/A	Storm Grate/Utility Hazard?	N/A
	Obstruction Type			Storm Grate/Utility Type	
		N/A			N/A
			Yes	Surface Condition? (G/P)	Good
			No	Curb Slope (%)	12.8

Remove & Replace Curb Ramp With Two New Directional Ramps or Equivalent.
