Access Compliance Report
Public Rights-of-Way
(Curb Ramps)

Intersection ID: 4268 | **Main Street:** VOELTZ_DR | **Cross Street:** TWIN_DR | **Location:** SE

ADA ID: 06B2F1D75BBD | **Ramp Type:** Perp | **Initial Pass/Fail:** Fail | **Overall Compliance:** No | **Severity Score:** 58.75

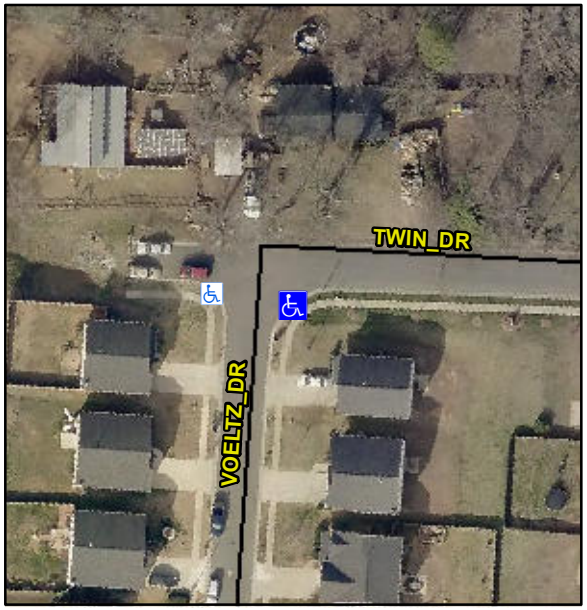
Not Found, R304.5.1, R304.2.2, R304.5.3

Compliance	Description	Data	Compliance	Description	Data
N/A	Ramp Length (in)	46.5	No	Ramp Slope (%)	13.3
No	Ramp Width (in)	47.0	No	Ramp XSlope (%)	7.6
N/A	Flare Type LT	N/A	N/A	Flare Type RT	N/A
N/A	Flare Slope LT (%)	N/A	N/A	Flare Slope RT (%)	N/A
N/A	Flare Traversable LT?	N/A	N/A	Flare Traversable RT?	N/A
N/A	Landing Length (in)	N/A	N/A	DWS Provided?	N/A
N/A	Landing Width (in)	N/A	N/A	DWS Contrast?	N/A
N/A	Landing Slope (%)	N/A	N/A	DWS Length (in)	N/A
N/A	Landing X Slope (%)	N/A	N/A	DWS Full Width?	N/A
N/A	Landing Curb? (Y/N)	N/A	N/A	DWS Offset (in)	N/A
N/A	Shared Landing?	N/A			
N/A	Gutter Ponding?	N/A	N/A	Gutter Slope (%)	N/A
N/A	Gutter Lip Ht (in)	N/A	N/A	Gutter X Slope (%)	N/A
N/A	Painted X Walk1?	No	N/A	Painted X Walk2?	N/A
	X Walk 1 Direction	To W		X Walk 2 Direction	N/A
N/A	X Walk 1 Width (in)	N/A	N/A	X Walk 2 Width (in)	N/A
	X Walk 1 Slope (%)	2.9		X Walk 2 Slope (%)	N/A
	X Walk 1 X Slope (%)	6.4		X Walk 2 X Slope (%)	N/A

Remove & Replace Entire Ramp.
