# Access Compliance Report
# Public Rights-of-Way
# (Curb Ramps)

| **Intersection ID: 21514** | **Main Street: E_ARROWOOD_RD** | **Cross Street: NATIONS_FORD_RD** | **Location: NW** |
| **ADA ID: 075485FD92CD** | **Ramp Type: BlendTrans1** | **Initial Pass/Fail: Pass** | **Overall Compliance: No** **Severity Score: 5** |

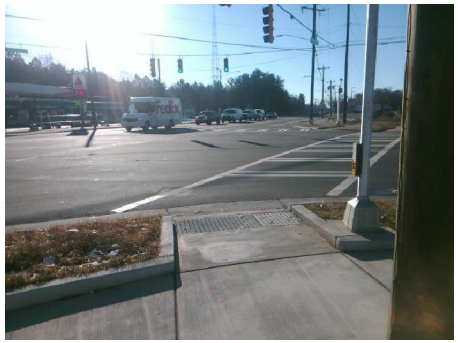
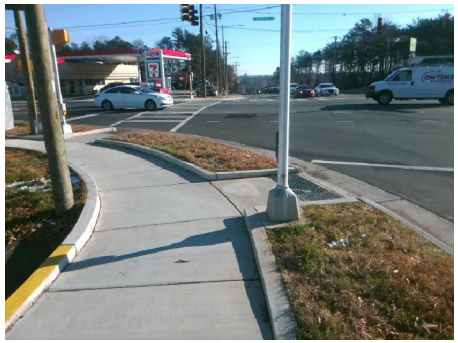
**Not Found, R305.2, R304.5.4**

| Compliance | Description | Data | Compliance | Description | Data |
|---|---|---|---|---|---|
| N/A | Landing Curb? (Y/N) | Yes | No | DWS Offset (in) | 2.5 |
| Yes | Gutter Ponding? | No | No | Gutter Slope (%) | 5.1 |
| | | | No | Curb Slope (%) | 8.4 |

**Remove & Replace Curb Ramp With Two New Directional Ramps or Equivalent. Remove & Replace Gutter.**
