Access Compliance Report
Public Rights-of-Way
(Curb Ramps)

Intersection ID: 44932	**Main Street:** NATHAN_DR	**Cross Street:** BRUMIT_LN	**Location:** SW
ADA ID: 0777D2F470B6	**Ramp Type:** PerpDiag	**Initial Pass/Fail:** Fail	**Overall Compliance:** No **Severity Score:** 8.75

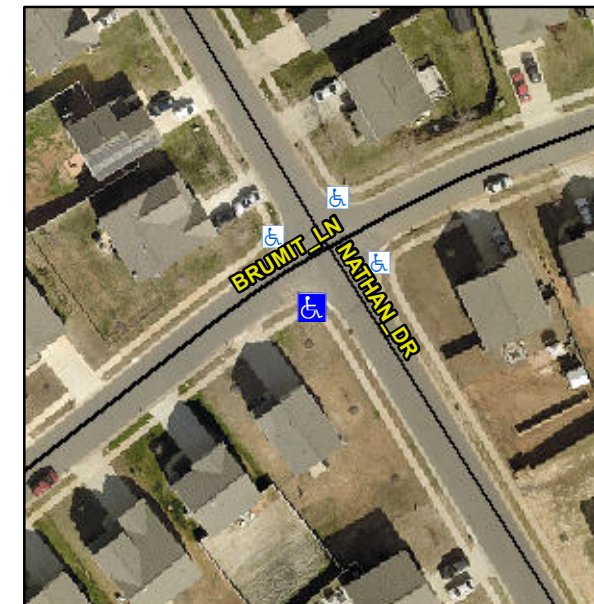
R304.5.1

Remove & Replace Curb Ramp With Two New Directional Ramps or Equivalent.
