Access Compliance Report

# Public Rights-of-Way
(Curb Ramps)

Intersection ID: 20660	Main Street: SANDY_PORTER_RD	Cross Street: STEELECHASE_DR	Location:	NW
ADA ID: 077F70D2F7F4	Ramp Type: Perp	Initial Pass/Fail: Fail	Overall Compliance: No	Severity Score: 12.5

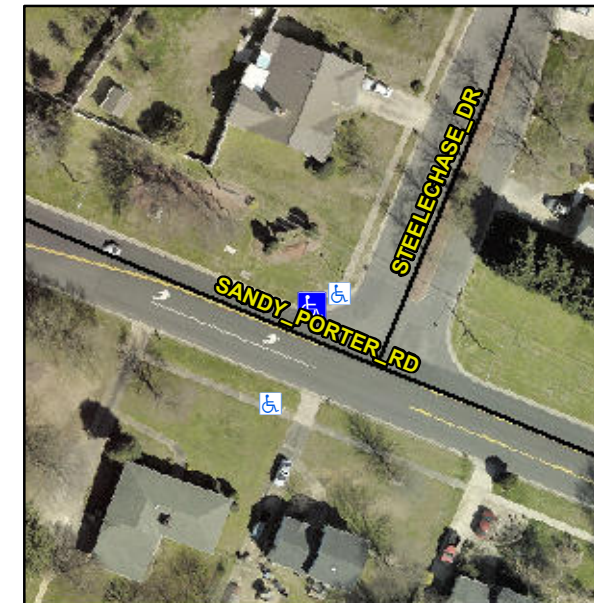
R304.5.3

Compliance	Description	Data	Compliance	Description	Data
N/A	Ramp Length (in)	95.0	Yes	Ramp Slope (%)	5.2
Yes	Ramp Width (in)	48.0	No	Ramp XSlope (%)	5.2
N/A	Flare Type LT	N/A	N/A	Flare Type RT	N/A
N/A	Flare Slope LT (%)	N/A	N/A	Flare Slope RT (%)	N/A
N/A	Flare Traversable LT?	N/A	N/A	Flare Traversable RT?	N/A
N/A	Landing Length (in)	N/A	N/A	DWS Provided?	N/A
N/A	Landing Width (in)	N/A	N/A	DWS Contrast?	N/A
N/A	Landing Slope (%)	N/A	N/A	DWS Length (in)	N/A
N/A	Landing X Slope (%)	N/A	N/A	DWS Full Width?	N/A
N/A	Landing Curb? (Y/N)	N/A	N/A	DWS Offset (in)	N/A
N/A	Shared Landing?	N/A			
N/A	Gutter Ponding?	N/A	N/A	Gutter Slope (%)	N/A
N/A	Gutter Lip Ht (in)	N/A	N/A	Gutter X Slope (%)	N/A
N/A	Painted X Walk1?	No	N/A	Painted X Walk2?	N/A
	X Walk 1 Direction	To SW		X Walk 2 Direction	N/A
N/A	X Walk 1 Width (in)	N/A	N/A	X Walk 2 Width (in)	N/A
	X Walk 1 Slope (%)	5.1		X Walk 2 Slope (%)	N/A
	X Walk 1 X Slope (%)	3.5		X Walk 2 X Slope (%)	N/A

Remove & Replace Entire Ramp.
