Access Compliance Report

# Public Rights-of-Way
(Curb Ramps)

Intersection ID: 26775	Main Street: CREEK_BEND_DR	Cross Street: ELM_CREEK_LN	Location: SE
ADA ID: 07856A443D6E	Ramp Type: PerpDiag	Initial Pass/Fail: Fail	Overall Compliance: No Severity Score: 21.25

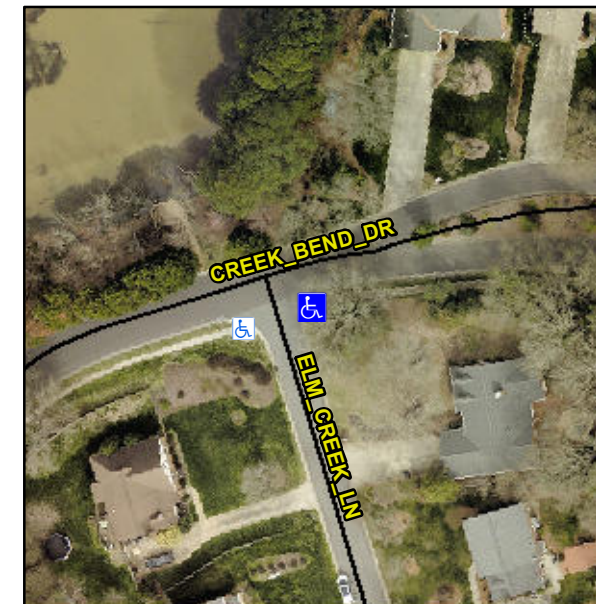
Not Found, R304.5.1, R304.2.2

Compliance	Description	Data	Compliance	Description	Data
N/A	Ramp Length (in)	26.0	No	Ramp Slope (%)	9.4
No	Ramp Width (in)	42.0	Yes	Ramp XSlope (%)	1.5
N/A	Flare Type LT	N/A	N/A	Flare Type RT	N/A
N/A	Flare Slope LT (%)	N/A	N/A	Flare Slope RT (%)	N/A
N/A	Flare Traversable LT?	N/A	N/A	Flare Traversable RT?	N/A
N/A	Landing Length (in)	N/A	N/A	DWS Provided?	N/A
N/A	Landing Width (in)	N/A	N/A	DWS Contrast?	N/A
N/A	Landing Slope (%)	N/A	N/A	DWS Length (in)	N/A
N/A	Landing X Slope (%)	N/A	N/A	DWS Full Width?	N/A
N/A	Landing Curb? (Y/N)	N/A	N/A	DWS Offset (in)	N/A
N/A	Shared Landing?	N/A			
N/A	Gutter Ponding?	N/A	N/A	Gutter Slope (%)	N/A
N/A	Gutter Lip Ht (in)	N/A	N/A	Gutter X Slope (%)	N/A
N/A	Painted X Walk1?	No	N/A	Painted X Walk2?	No
	X Walk 1 Direction	To N		X Walk 2 Direction	To W
N/A	X Walk 1 Width (in)	N/A	N/A	X Walk 2 Width (in)	N/A
	X Walk 1 Slope (%)	1.8		X Walk 2 Slope (%)	2.8
	X Walk 1 X Slope (%)	0.1		X Walk 2 X Slope (%)	2.2

Remove & Replace Curb Ramp With Two New Directional Ramps or Equivalent.
