Access Compliance Report
Public Rights-of-Way
(Curb Ramps)

Intersection ID: 45518 **Main Street:** COTTON_PRESS_RD **Cross Street:** MEADOW_BOTTOM_RD **Location:** N

ADA ID: 07D685E80168 **Ramp Type:** PerpDiag **Initial Pass/Fail:** Fail **Overall Compliance:** No **Severity Score:** 22.5

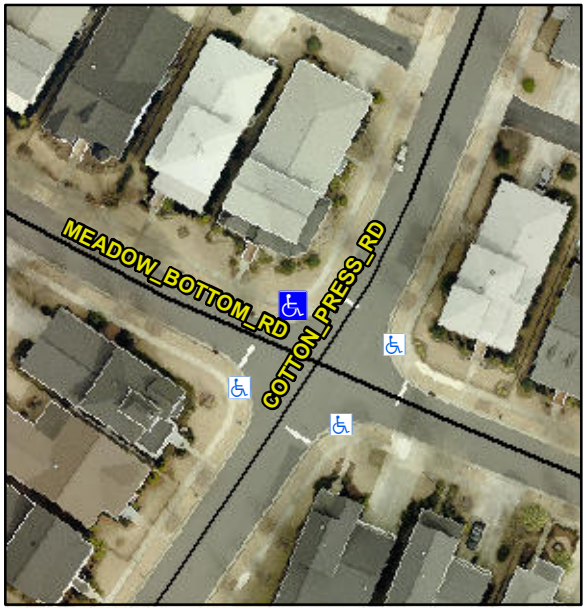
Not Found, R304.5.1, R304.2.2, R304.5.3

Compliance	Description	Data	Compliance	Description	Data
N/A	Ramp Length (in)	72.0	No	Ramp Slope (%)	10.7
No	Ramp Width (in)	41.0	No	Ramp XSlope (%)	4.5
N/A	Flare Type LT	N/A	N/A	Flare Type RT	N/A
N/A	Flare Slope LT (%)	N/A	N/A	Flare Slope RT (%)	N/A
N/A	Flare Traversable LT?	N/A	N/A	Flare Traversable RT?	N/A
N/A	Landing Length (in)	N/A	N/A	DWS Provided?	N/A
N/A	Landing Width (in)	N/A	N/A	DWS Contrast?	N/A
N/A	Landing Slope (%)	N/A	N/A	DWS Length (in)	N/A
N/A	Landing X Slope (%)	N/A	N/A	DWS Full Width?	N/A
N/A	Landing Curb? (Y/N)	N/A	N/A	DWS Offset (in)	N/A
N/A	Shared Landing?	N/A			
N/A	Gutter Ponding?	N/A	N/A	Gutter Slope (%)	N/A
N/A	Gutter Lip Ht (in)	N/A	N/A	Gutter X Slope (%)	N/A
N/A	Painted X Walk1?	No	N/A	Painted X Walk2?	No
	X Walk 1 Direction	To SW		X Walk 2 Direction	To SE
N/A	X Walk 1 Width (in)	N/A	N/A	X Walk 2 Width (in)	N/A
	X Walk 1 Slope (%)	0.1		X Walk 2 Slope (%)	2.7
	X Walk 1 X Slope (%)	1.5		X Walk 2 X Slope (%)	2.1

Remove & Replace Curb Ramp With Two New Directional Ramps or Equivalent.
