Access Compliance Report
Public Rights-of-Way
(Curb Ramps)

Intersection ID: 13654	**Main Street: S_TRYON_ST**	**Cross Street: W_PARK_AV**	**Location: S**
ADA ID: 0840A38B6FDD	**Ramp Type: Perp**	**Initial Pass/Fail: Fail**	**Overall Compliance: No** / **Severity Score: 13.75**

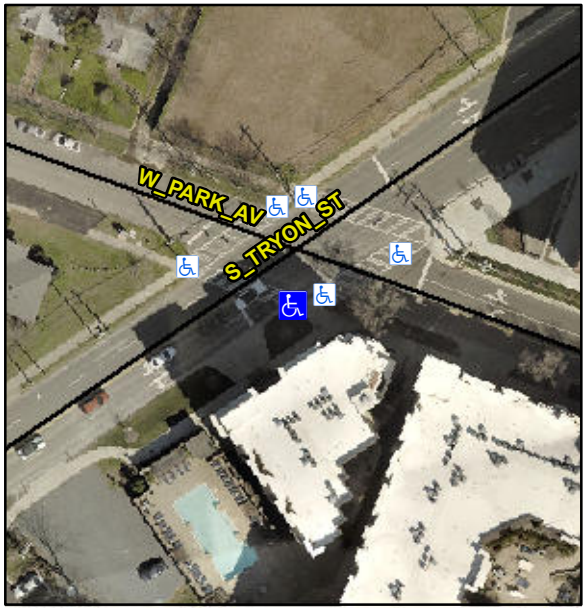
R304.2.2

Compliance	Description	Data	Compliance	Description	Data
N/A	Ramp Length (in)	27.0	No	Ramp Slope (%)	10.9
Yes	Ramp Width (in)	106.0	Yes	Ramp XSlope (%)	3.2
N/A	Flare Type LT	N/A	N/A	Flare Type RT	N/A
N/A	Flare Slope LT (%)	N/A	N/A	Flare Slope RT (%)	N/A
N/A	Flare Traversable LT?	N/A	N/A	Flare Traversable RT?	N/A
N/A	Landing Length (in)	N/A	N/A	DWS Provided?	N/A
N/A	Landing Width (in)	N/A	N/A	DWS Contrast?	N/A
N/A	Landing Slope (%)	N/A	N/A	DWS Length (in)	N/A
N/A	Landing X Slope (%)	N/A	N/A	DWS Full Width?	N/A
N/A	Landing Curb? (Y/N)	N/A	N/A	DWS Offset (in)	N/A
N/A	Shared Landing?	N/A			
N/A	Gutter Ponding?	N/A	N/A	Gutter Slope (%)	N/A
N/A	Gutter Lip Ht (in)	N/A	N/A	Gutter X Slope (%)	N/A
N/A	Painted X Walk1?	Yes	N/A	Painted X Walk2?	N/A
	X Walk 1 Direction	To NW		X Walk 2 Direction	N/A
N/A	X Walk 1 Width (in)	111.0	N/A	X Walk 2 Width (in)	N/A
	X Walk 1 Slope (%)	4.3		X Walk 2 Slope (%)	N/A

Remove & Replace Entire Ramp.

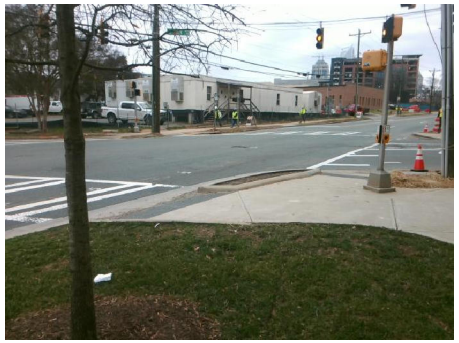
X Walk 1 X Slope (%)	6.2		X Walk 2 X Slope (%)	N/A
N/A	Ramp inside XWalk1?	Yes	N/A	Ramp inside XWalk2?	N/A
	Road Slope (%)	N/A	N/A	Clear Space?	N/A
	Road X Slope (%)	N/A	N/A	Clear Space to XWalk (in)	N/A
N/A	Any Obstructions?	N/A	N/A	Storm Grate/Utility Hazard?	N/A
	Obstruction Type			Storm Grate/Utility Type	
		N/A			N/A
			Yes	Surface Condition? (G/P)	Good
