Access Compliance Report
Public Rights-of-Way
(Curb Ramps)

Intersection ID: 27468 **Main Street:** BALLANTYNE_COMMONS_PY **Cross Street:** JOHN_J_DELANEY_DR **Location:** SE

ADA ID: 085338C588B9 **Ramp Type:** Perp **Initial Pass/Fail:** Fail **Overall Compliance:** No **Severity Score:** 12.5

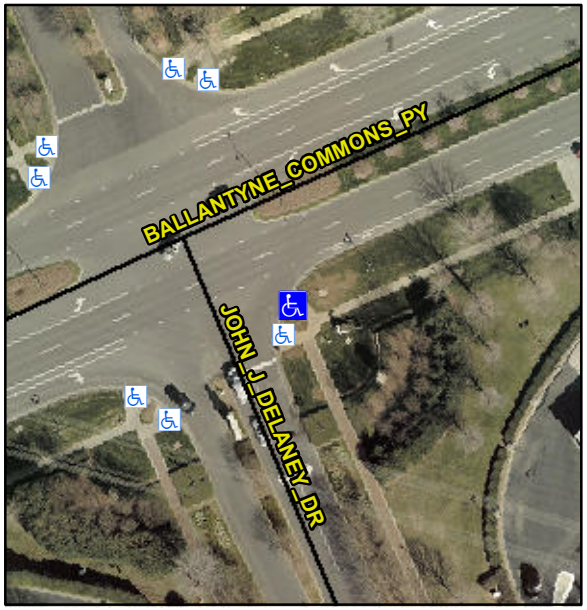
Not Found, R304.5.3

Remove & Replace Entire Ramp.
