Access Compliance Report
Public Rights-of-Way
(Curb Ramps)

Intersection ID: 30033 **Main Street:** DILLARD_RIDGE_DR **Cross Street:** SOUTHWIND_DR **Location:** E

ADA ID: 08C11A3A70C6 **Ramp Type:** Combination1Diag **Initial Pass/Fail:** Fail **Overall Compliance:** No **Severity Score:** 0

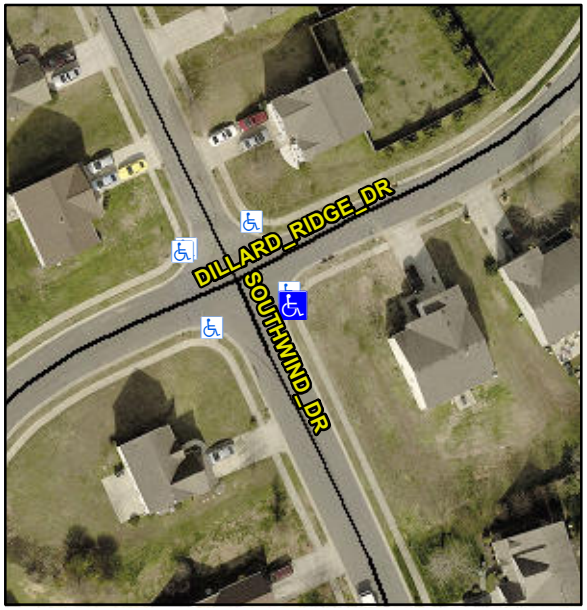
R304.5.1, R304.2.2, R304.5.3, R304.3.2

Compliance	Description	Data	Compliance	Description	Data
N/A	Ramp Length LT (in)	57.0	N/A	Ramp Length RT (in)	71.0
Yes	Ramp Width LT (in)	48.0	Yes	Ramp Width RT (in)	48.0
No	Ramp Slope LT (%)	16.6	No	Ramp Slope RT (%)	11.5
No	Ramp XSlope LT (%)	4.0	Yes	Ramp XSlope RT (%)	1.8
N/A	Ramp Length (in)	50.0	No	Ramp Slope (%)	17.0
No	Ramp Width (in)	39.0	No	Ramp XSlope (%)	10.2
N/A	Flare Type LT	N/A	N/A	Flare Type RT	N/A
N/A	Flare Slope LT (%)	N/A	N/A	Flare Slope RT (%)	N/A
N/A	Flare Traversable LT?	N/A	N/A	Flare Traversable RT?	N/A
N/A	Landing Length (in)	N/A	N/A	DWS Provided?	N/A
N/A	Landing Width (in)	N/A	N/A	DWS Contrast?	N/A
N/A	Landing Slope (%)	N/A	N/A	DWS Length (in)	N/A
N/A	Landing X Slope (%)	N/A	N/A	DWS Full Width?	N/A
N/A	Landing Curb? (Y/N)	N/A	N/A	DWS Offset (in)	N/A
N/A	Shared Landing?	N/A			
N/A	Gutter Ponding?	N/A	N/A	Gutter Slope (%)	N/A
N/A	Gutter Lip Ht (in)	N/A	N/A	Gutter X Slope (%)	N/A
N/A	Painted X Walk1?	No	N/A	Painted X Walk2?	No

Remove & Replace Curb Ramp With Two New Directional Ramps or Equivalent.
