Access Compliance Report
Public Rights-of-Way
(Curb Ramps)

Intersection ID: 3003	**Main Street: GOLDEN_POND_DR**	**Cross Street: WOODFIRE_RD**	**Location: NE**
ADA ID: 08D7BE1D831B	**Ramp Type: Perp**	**Initial Pass/Fail: Fail**	**Overall Compliance: No** / **Severity Score: 12.5**

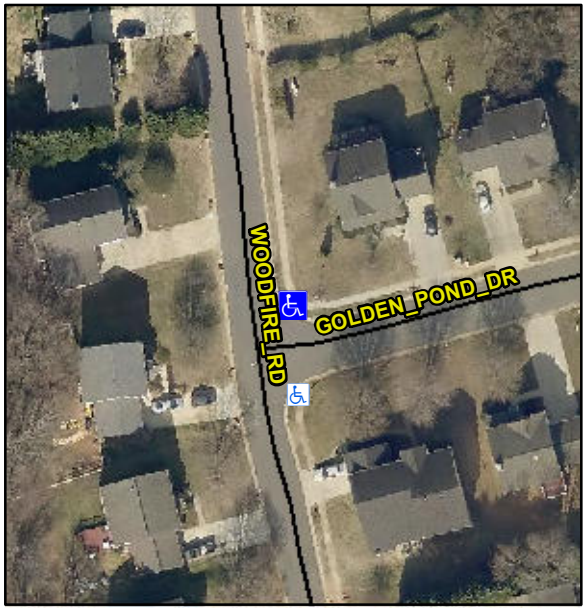
Not Found, R304.5.3

Compliance	Description	Data	Compliance	Description	Data
N/A	Ramp Length (in)	93.0	Yes	Ramp Slope (%)	5.2
Yes	Ramp Width (in)	48.0	No	Ramp XSlope (%)	5.7
N/A	Flare Type LT	N/A	N/A	Flare Type RT	N/A
N/A	Flare Slope LT (%)	N/A	N/A	Flare Slope RT (%)	N/A
N/A	Flare Traversable LT?	N/A	N/A	Flare Traversable RT?	N/A
N/A	Landing Length (in)	N/A	N/A	DWS Provided?	N/A
N/A	Landing Width (in)	N/A	N/A	DWS Contrast?	N/A
N/A	Landing Slope (%)	N/A	N/A	DWS Length (in)	N/A
N/A	Landing X Slope (%)	N/A	N/A	DWS Full Width?	N/A
N/A	Landing Curb? (Y/N)	N/A	N/A	DWS Offset (in)	N/A
N/A	Shared Landing?	N/A			
N/A	Gutter Ponding?	N/A	N/A	Gutter Slope (%)	N/A
N/A	Gutter Lip Ht (in)	N/A	N/A	Gutter X Slope (%)	N/A
N/A	Painted X Walk1?	No	N/A	Painted X Walk2?	N/A
	X Walk 1 Direction	To S		X Walk 2 Direction	N/A
N/A	X Walk 1 Width (in)	N/A	N/A	X Walk 2 Width (in)	N/A
	X Walk 1 Slope (%)	8.7		X Walk 2 Slope (%)	N/A
	X Walk 1 X Slope (%)	3.5		X Walk 2 X Slope (%)	N/A

Remove & Replace Entire Ramp.
