Access Compliance Report
Public Rights-of-Way
(Curb Ramps)

Intersection ID: 10023486	**Main Street:** CIRCUMFERENTIAL_RD	**Cross Street: N/A**	**Location:**	**SW**
ADA ID: 090D12BFA8A4	**Ramp Type:** Perp	**Initial Pass/Fail:** Fail	**Overall Compliance:** No	**Severity Score:** 21.25

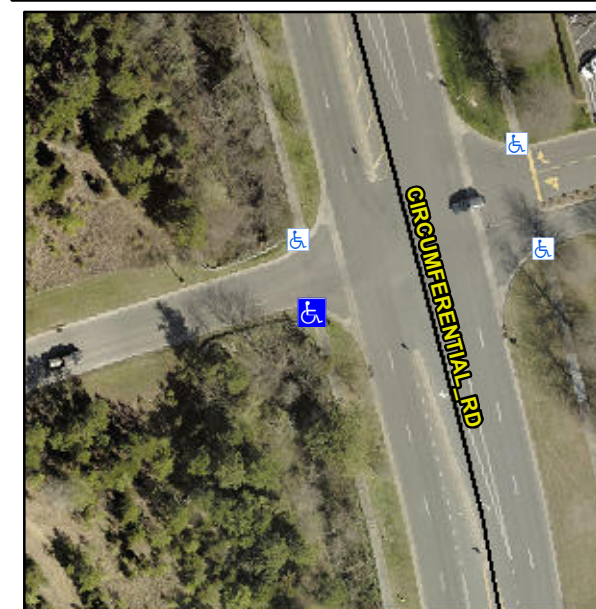
R304.5.1, R304.5.3

Compliance	Description	Data	Compliance	Description	Data
N/A	Ramp Length (in)	45.0	Yes	Ramp Slope (%)	3.1
No	Ramp Width (in)	45.0	No	Ramp XSlope (%)	5.4
N/A	Flare Type LT	N/A	N/A	Flare Type RT	N/A
N/A	Flare Slope LT (%)	N/A	N/A	Flare Slope RT (%)	N/A
N/A	Flare Traversable LT?	N/A	N/A	Flare Traversable RT?	N/A
N/A	Landing Length (in)	N/A	N/A	DWS Provided?	N/A
N/A	Landing Width (in)	N/A	N/A	DWS Contrast?	N/A
N/A	Landing Slope (%)	N/A	N/A	DWS Length (in)	N/A
N/A	Landing X Slope (%)	N/A	N/A	DWS Full Width?	N/A
N/A	Landing Curb? (Y/N)	N/A	N/A	DWS Offset (in)	N/A
N/A	Shared Landing?	N/A			
N/A	Gutter Ponding?	N/A	N/A	Gutter Slope (%)	N/A
N/A	Gutter Lip Ht (in)	N/A	N/A	Gutter X Slope (%)	N/A
N/A	Painted X Walk1?	No	N/A	Painted X Walk2?	N/A
	X Walk 1 Direction	To N		X Walk 2 Direction	N/A
N/A	X Walk 1 Width (in)	N/A	N/A	X Walk 2 Width (in)	N/A
	X Walk 1 Slope (%)	1.8		X Walk 2 Slope (%)	N/A
	X Walk 1 X Slope (%)	3.6		X Walk 2 X Slope (%)	N/A

Remove & Replace Entire Ramp.

Total Cost: $ 1850.00
