Access Compliance Report
Public Rights-of-Way
(Curb Ramps)

Intersection ID: 11256	Main Street: N_IRWIN_AV	Cross Street: W_5TH_ST	Location: E
ADA ID: 0A4F73CF0FD1	Ramp Type: Perp	Initial Pass/Fail: Fail	Overall Compliance: No	Severity Score: 12.5

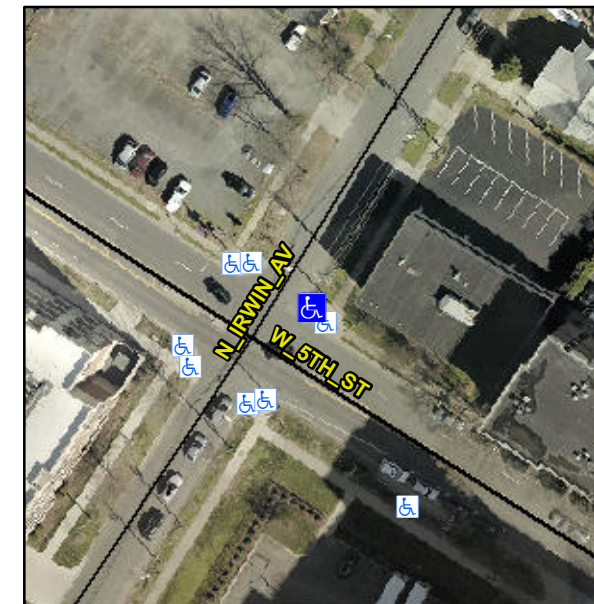
Not Found, R304.5.3

Compliance	Description	Data	Compliance	Description	Data
N/A	Ramp Length (in)	85.0	Yes	Ramp Slope (%)	5.3
Yes	Ramp Width (in)	49.0	No	Ramp XSlope (%)	6.5
N/A	Flare Type LT	N/A	N/A	Flare Type RT	N/A
N/A	Flare Slope LT (%)	N/A	N/A	Flare Slope RT (%)	N/A
N/A	Flare Traversable LT?	N/A	N/A	Flare Traversable RT?	N/A
N/A	Landing Length (in)	N/A	N/A	DWS Provided?	N/A
N/A	Landing Width (in)	N/A	N/A	DWS Contrast?	N/A
N/A	Landing Slope (%)	N/A	N/A	DWS Length (in)	N/A
N/A	Landing X Slope (%)	N/A	N/A	DWS Full Width?	N/A
N/A	Landing Curb? (Y/N)	N/A	N/A	DWS Offset (in)	N/A
N/A	Shared Landing?	N/A			
N/A	Gutter Ponding?	N/A	N/A	Gutter Slope (%)	N/A
N/A	Gutter Lip Ht (in)	N/A	N/A	Gutter X Slope (%)	N/A
N/A	Painted X Walk1?	No	N/A	Painted X Walk2?	N/A
	X Walk 1 Direction	To NW		X Walk 2 Direction	N/A
N/A	X Walk 1 Width (in)	N/A	N/A	X Walk 2 Width (in)	N/A
	X Walk 1 Slope (%)	0.5		X Walk 2 Slope (%)	N/A
	X Walk 1 X Slope (%)	2.9		X Walk 2 X Slope (%)	N/A

Remove & Replace Entire Ramp.
