Access Compliance Report
Public Rights-of-Way
(Curb Ramps)

Intersection ID: 10038262 **Main Street:** SMITH_RD **Cross Street:** N/A **Location:** SW

ADA ID: 0A9EEFDEFDC7 **Ramp Type:** PerpDiag **Initial Pass/Fail:** Fail **Overall Compliance:** No **Severity Score:** 22.5

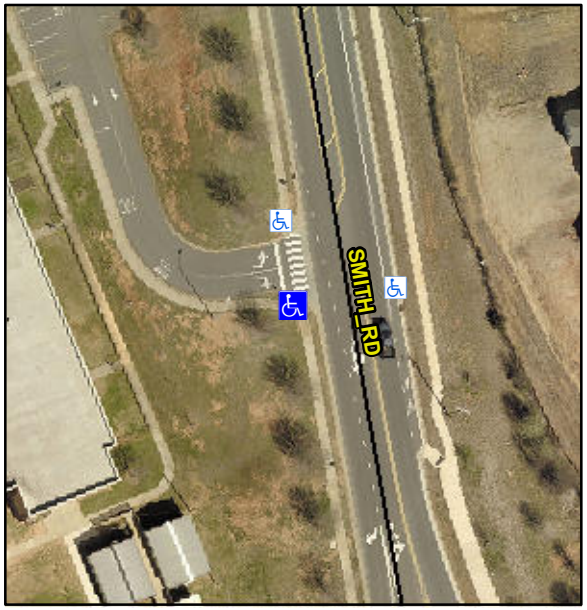
Not Found, R304.5.1, R304.2.2, R304.5.3

Compliance	Description	Data	Compliance	Description	Data
N/A	Ramp Length (in)	47.0	No	Ramp Slope (%)	9.2
No	Ramp Width (in)	47.0	No	Ramp XSlope (%)	2.7
N/A	Flare Type LT	N/A	N/A	Flare Type RT	N/A
N/A	Flare Slope LT (%)	N/A	N/A	Flare Slope RT (%)	N/A
N/A	Flare Traversable LT?	N/A	N/A	Flare Traversable RT?	N/A
N/A	Landing Length (in)	N/A	N/A	DWS Provided?	N/A
N/A	Landing Width (in)	N/A	N/A	DWS Contrast?	N/A
N/A	Landing Slope (%)	N/A	N/A	DWS Length (in)	N/A
N/A	Landing X Slope (%)	N/A	N/A	DWS Full Width?	N/A
N/A	Landing Curb? (Y/N)	N/A	N/A	DWS Offset (in)	N/A
N/A	Shared Landing?	N/A			
N/A	Gutter Ponding?	N/A	N/A	Gutter Slope (%)	N/A
N/A	Gutter Lip Ht (in)	N/A	N/A	Gutter X Slope (%)	N/A
N/A	Painted X Walk1?	No	N/A	Painted X Walk2?	Yes
	X Walk 1 Direction	To E		X Walk 2 Direction	To N
N/A	X Walk 1 Width (in)	N/A	N/A	X Walk 2 Width (in)	96.0
	X Walk 1 Slope (%)	2.0		X Walk 2 Slope (%)	3.0
	X Walk 1 X Slope (%)	2.2		X Walk 2 X Slope (%)	1.1

Remove & Replace Curb Ramp With Two New Directional Ramps or Equivalent.
