# Access Compliance Report
Public Rights-of-Way
(Curb Ramps)

Intersection ID: 5714	Main Street: JOHN_KIRK_DR	Cross Street: UNIVERSTIY_CITY_BV	Location:	N
ADA ID: 0B7685B850F7	Ramp Type: Perp	Initial Pass/Fail: Fail	Overall Compliance: No	Severity Score: 12.5

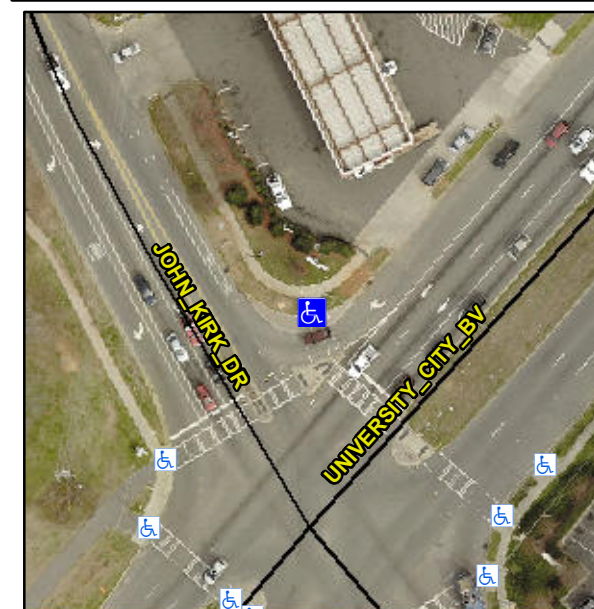
Compliance	Description	Data	Compliance	Description	Data
N/A	Ramp Length (in)	88.0	No	Ramp Slope (%)	10.0
Yes	Ramp Width (in)	72.0	Yes	Ramp XSlope (%)	0.2
N/A	Flare Type LT	N/A	N/A	Flare Type RT	N/A
N/A	Flare Slope LT (%)	N/A	N/A	Flare Slope RT (%)	N/A
N/A	Flare Traversable LT?	N/A	N/A	Flare Traversable RT?	N/A
N/A	Landing Length (in)	N/A	N/A	DWS Provided?	N/A
N/A	Landing Width (in)	N/A	N/A	DWS Contrast?	N/A
N/A	Landing Slope (%)	N/A	N/A	DWS Length (in)	N/A
N/A	Landing X Slope (%)	N/A	N/A	DWS Full Width?	N/A
N/A	Landing Curb? (Y/N)	N/A	N/A	DWS Offset (in)	N/A
N/A	Shared Landing?	N/A			
N/A	Gutter Ponding?	N/A	N/A	Gutter Slope (%)	N/A
N/A	Gutter Lip Ht (in)	N/A	N/A	Gutter X Slope (%)	N/A
N/A	Painted X Walk1?	Yes	N/A	Painted X Walk2?	N/A
	X Walk 1 Direction	To S		X Walk 2 Direction	N/A
N/A	X Walk 1 Width (in)	90.0	N/A	X Walk 2 Width (in)	N/A
	X Walk 1 Slope (%)	4.0		X Walk 2 Slope (%)	N/A
	X Walk 1 X Slope (%)	1.2		X Walk 2 X Slope (%)	N/A

Remove & Replace Entire Ramp.
