Access Compliance Report
Public Rights-of-Way
(Curb Ramps)

Intersection ID: 10181	Main Street: BACON_AV	Cross Street: ROSLYN_AV	Location:	E
ADA ID: 0BB744597086	Ramp Type: PerpDiag	Initial Pass/Fail: Fail	Overall Compliance: No	Severity Score: 35

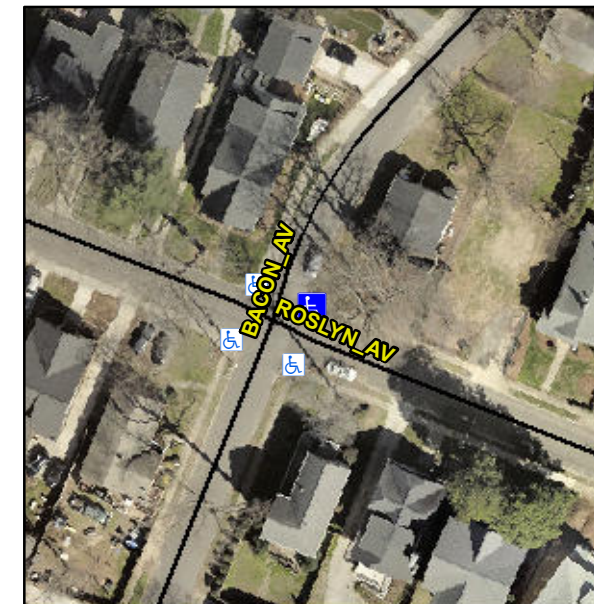
Not Found, R304.5.1

Compliance	Description	Data	Compliance	Description	Data
N/A	Ramp Length (in)	75.5	Yes	Ramp Slope (%)	6.8
No	Ramp Width (in)	30.0	Yes	Ramp XSlope (%)	0.7
N/A	Flare Type LT	N/A	N/A	Flare Type RT	N/A
N/A	Flare Slope LT (%)	N/A	N/A	Flare Slope RT (%)	N/A
N/A	Flare Traversable LT?	N/A	N/A	Flare Traversable RT?	N/A
N/A	Landing Length (in)	N/A	N/A	DWS Provided?	N/A
N/A	Landing Width (in)	N/A	N/A	DWS Contrast?	N/A
N/A	Landing Slope (%)	N/A	N/A	DWS Length (in)	N/A
N/A	Landing X Slope (%)	N/A	N/A	DWS Full Width?	N/A
N/A	Landing Curb? (Y/N)	N/A	N/A	DWS Offset (in)	N/A
N/A	Shared Landing?	N/A			
N/A	Gutter Ponding?	N/A	N/A	Gutter Slope (%)	N/A
N/A	Gutter Lip Ht (in)	N/A	N/A	Gutter X Slope (%)	N/A
N/A	Painted X Walk1?	No	N/A	Painted X Walk2?	No
	X Walk 1 Direction	To NW		X Walk 2 Direction	To SW
N/A	X Walk 1 Width (in)	N/A	N/A	X Walk 2 Width (in)	N/A
	X Walk 1 Slope (%)	1.9		X Walk 2 Slope (%)	0.7
	X Walk 1 X Slope (%)	0.9		X Walk 2 X Slope (%)	0.5

N/A	Ramp inside XWalk1?	N/A	N/A	Ramp inside XWalk2?	N/A
	Road Slope (%)	0.2	N/A	Clear Space?	N/A
	Road X Slope (%)	0.8	N/A	Clear Space to XWalk (in)	N/A
N/A	Any Obstructions?	N/A	N/A	Storm Grate/Utility Hazard?	N/A
	Obstruction Type			Storm Grate/Utility Type	
		N/A			N/A
			Yes	Surface Condition? (G/P)	Good

Remove & Replace Curb Ramp With Two New Directional Ramps or Equivalent.
