Access Compliance Report
Public Rights-of-Way
(Curb Ramps)

Intersection ID: N/A	Main Street: SILVER_CRESCENT_DR	Cross Street: AYRSLEY_TOWN_BV	Location:	SW
ADA ID: 0C6B8C9C4C06	Ramp Type: Perp	Initial Pass/Fail: Fail	Overall Compliance: No	Severity Score: 8.75

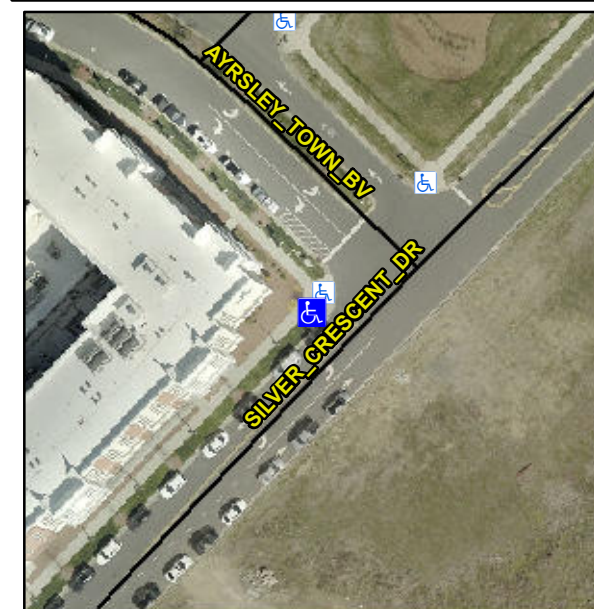
Not Found, R304.5.1

Compliance	Description	Data	Compliance	Description	Data
N/A	Ramp Length (in)	98.0	Yes	Ramp Slope (%)	7.0
No	Ramp Width (in)	47.0	Yes	Ramp XSlope (%)	0.6
N/A	Flare Type LT	N/A	N/A	Flare Type RT	N/A
N/A	Flare Slope LT (%)	N/A	N/A	Flare Slope RT (%)	N/A
N/A	Flare Traversable LT?	N/A	N/A	Flare Traversable RT?	N/A
N/A	Landing Length (in)	N/A	N/A	DWS Provided?	N/A
N/A	Landing Width (in)	N/A	N/A	DWS Contrast?	N/A
N/A	Landing Slope (%)	N/A	N/A	DWS Length (in)	N/A
N/A	Landing X Slope (%)	N/A	N/A	DWS Full Width?	N/A
N/A	Landing Curb? (Y/N)	N/A	N/A	DWS Offset (in)	N/A
N/A	Shared Landing?	N/A			
N/A	Gutter Ponding?	N/A	N/A	Gutter Slope (%)	N/A
N/A	Gutter Lip Ht (in)	N/A	N/A	Gutter X Slope (%)	N/A
N/A	Painted X Walk1?	No	N/A	Painted X Walk2?	N/A
	X Walk 1 Direction	To SE		X Walk 2 Direction	N/A
N/A	X Walk 1 Width (in)	N/A	N/A	X Walk 2 Width (in)	N/A
	X Walk 1 Slope (%)	5.8		X Walk 2 Slope (%)	N/A
	X Walk 1 X Slope (%)	2.2		X Walk 2 X Slope (%)	N/A

Remove & Replace Entire Ramp.
