Access Compliance Report
Public Rights-of-Way
(Curb Ramps)

Intersection ID: 53897 **Main Street:** ELGIN_MOOR_RD **Cross Street:** DALLAS_BAY_RD **Location:** N

ADA ID: 0CD0ACADD130 **Ramp Type:** Perp **Initial Pass/Fail:** Fail **Overall Compliance:** No **Severity Score:** 25

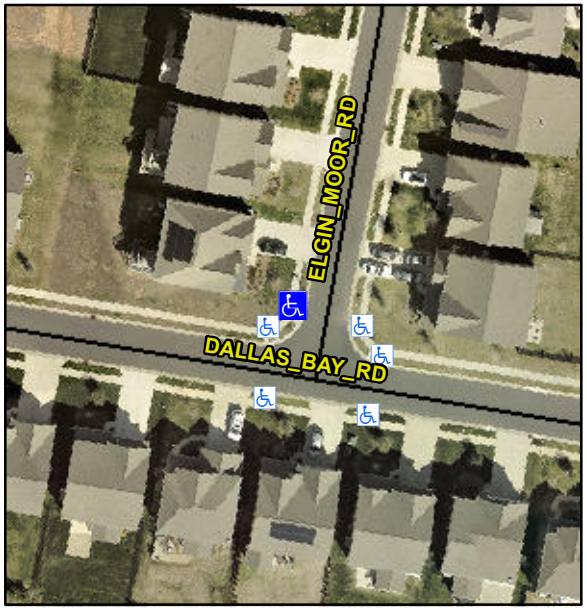
Not Found, R304.5.3

Compliance	Description	Data	Compliance	Description	Data
N/A	Ramp Length (in)	48.0	Yes	Ramp Slope (%)	6.0
Yes	Ramp Width (in)	48.0	No	Ramp XSlope (%)	8.1
N/A	Flare Type LT	N/A	N/A	Flare Type RT	N/A
N/A	Flare Slope LT (%)	N/A	N/A	Flare Slope RT (%)	N/A
N/A	Flare Traversable LT?	N/A	N/A	Flare Traversable RT?	N/A
N/A	Landing Length (in)	N/A	N/A	DWS Provided?	N/A
N/A	Landing Width (in)	N/A	N/A	DWS Contrast?	N/A
N/A	Landing Slope (%)	N/A	N/A	DWS Length (in)	N/A
N/A	Landing X Slope (%)	N/A	N/A	DWS Full Width?	N/A
N/A	Landing Curb? (Y/N)	N/A	N/A	DWS Offset (in)	N/A
N/A	Shared Landing?	N/A			
N/A	Gutter Ponding?	N/A	N/A	Gutter Slope (%)	N/A
N/A	Gutter Lip Ht (in)	1.5	N/A	Gutter X Slope (%)	N/A
N/A	Painted X Walk1?	No	N/A	Painted X Walk2?	N/A
	X Walk 1 Direction	To SE		X Walk 2 Direction	N/A
N/A	X Walk 1 Width (in)	N/A	N/A	X Walk 2 Width (in)	N/A
	X Walk 1 Slope (%)	0.7		X Walk 2 Slope (%)	N/A
	X Walk 1 X Slope (%)	2.5		X Walk 2 X Slope (%)	N/A

Remove & Replace Entire Ramp.
