# Access Compliance Report
# Public Rights-of-Way
# (Curb Ramps)

| Intersection ID: 22303 | Main Street: SHARON_VIEW_RD | Cross Street: GAYWIND_DR | Location: | E |
| ADA ID: 0D0561A44C2B | Ramp Type: PerpDiag | Initial Pass/Fail: Fail | Overall Compliance: No | Severity Score: 12.5 |

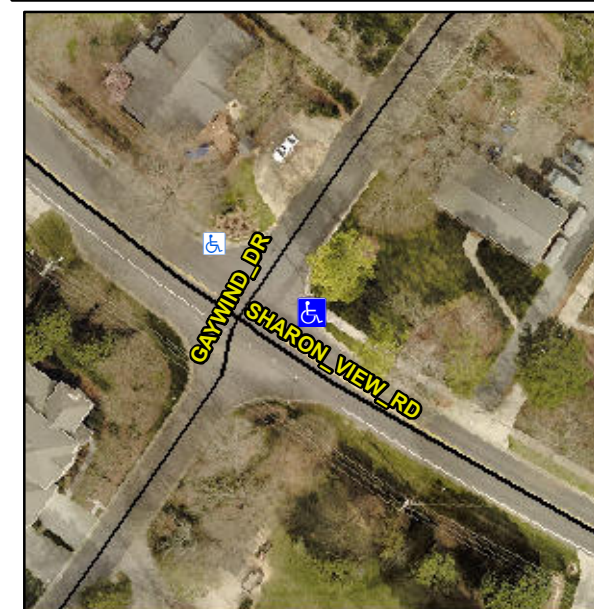
**Not Found, R304.2.2**

| Compliance | Description | Data | Compliance | Description | Data |
|---|---|---|---|---|---|
| N/A | Ramp Length (in) | 55.0 | No | Ramp Slope (%) | 8.9 |

**Remove & Replace Curb Ramp With Two New Directional Ramps or Equivalent.**
