Access Compliance Report
Public Rights-of-Way
(Curb Ramps)

Intersection ID: 8938 | **Main Street:** NORRIS_AV | **Cross Street:** NEWLAND_RD | **Location:** NE

ADA ID: 0EF5733D3E0B | **Ramp Type:** Perp | **Initial Pass/Fail:** Fail | **Overall Compliance:** No | **Severity Score:** 21.25

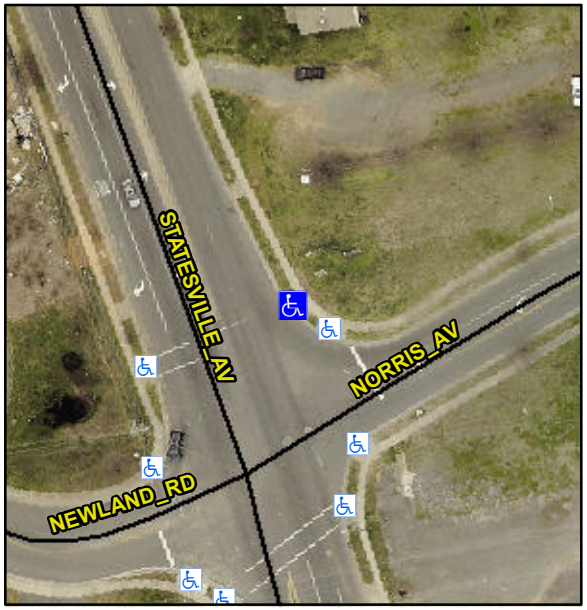
Not Found, R304.5.1, R304.2.2

Remove & Replace Entire Ramp.

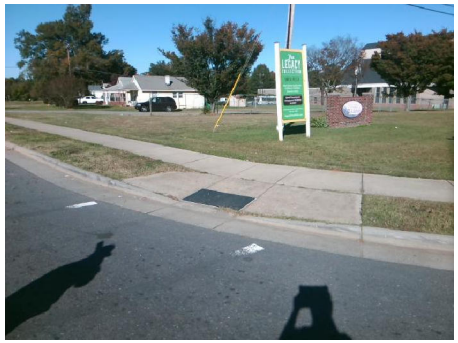
Compliance	Description	Data	Compliance	Description	Data
N/A	Ramp Length (in)	59.0	No	Ramp Slope (%)	11.1
No	Ramp Width (in)	41.0	Yes	Ramp XSlope (%)	0.9
N/A	Flare Type LT	N/A	N/A	Flare Type RT	N/A
N/A	Flare Slope LT (%)	N/A	N/A	Flare Slope RT (%)	N/A
N/A	Flare Traversable LT?	N/A	N/A	Flare Traversable RT?	N/A
N/A	Landing Length (in)	N/A	N/A	DWS Provided?	N/A
N/A	Landing Width (in)	N/A	N/A	DWS Contrast?	N/A
N/A	Landing Slope (%)	N/A	N/A	DWS Length (in)	N/A
N/A	Landing X Slope (%)	N/A	N/A	DWS Full Width?	N/A
N/A	Landing Curb? (Y/N)	N/A	N/A	DWS Offset (in)	N/A
N/A	Shared Landing?	N/A			
N/A	Gutter Ponding?	N/A	N/A	Gutter Slope (%)	N/A
N/A	Gutter Lip Ht (in)	N/A	N/A	Gutter X Slope (%)	N/A
N/A	Painted X Walk1?	No	N/A	Painted X Walk2?	N/A
	X Walk 1 Direction	To SW		X Walk 2 Direction	N/A
N/A	X Walk 1 Width (in)	N/A	N/A	X Walk 2 Width (in)	N/A
	X Walk 1 Slope (%)	2.7		X Walk 2 Slope (%)	N/A

X Walk 1 X Slope (%)	0.5		X Walk 2 X Slope (%)	N/A
N/A	Ramp inside XWalk1?	N/A	N/A	Ramp inside XWalk2?	N/A
	Road Slope (%)	N/A	N/A	Clear Space?	N/A
	Road X Slope (%)	N/A	N/A	Clear Space to XWalk (in)	N/A
N/A	Any Obstructions?	N/A	N/A	Storm Grate/Utility Hazard?	N/A
	Obstruction Type			Storm Grate/Utility Type	
		N/A			N/A
			Yes	Surface Condition? (G/P)	Good
