Access Compliance Report
Public Rights-of-Way
(Curb Ramps)

Intersection ID: 47849	Main Street: SERAPE_RD	Cross Street: STONE_PORCH_RD	Location:	SE
ADA ID: 0F37359AD6F6	Ramp Type: PerpDiag	Initial Pass/Fail: Fail	Overall Compliance: No	Severity Score: 12.5

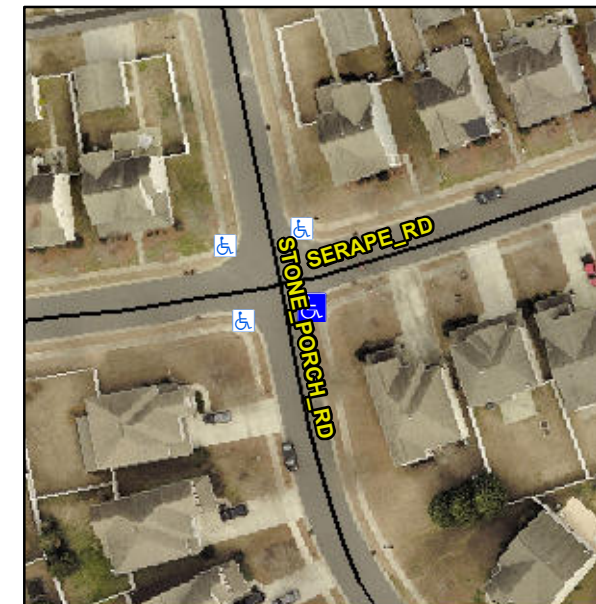
R304.5.3

Compliance	Description	Data	Compliance	Description	Data
N/A	Ramp Length (in)	52.0	Yes	Ramp Slope (%)	5.2
Yes	Ramp Width (in)	49.0	No	Ramp XSlope (%)	5.5
N/A	Flare Type LT	N/A	N/A	Flare Type RT	N/A
N/A	Flare Slope LT (%)	N/A	N/A	Flare Slope RT (%)	N/A
N/A	Flare Traversable LT?	N/A	N/A	Flare Traversable RT?	N/A
N/A	Landing Length (in)	N/A	N/A	DWS Provided?	N/A
N/A	Landing Width (in)	N/A	N/A	DWS Contrast?	N/A
N/A	Landing Slope (%)	N/A	N/A	DWS Length (in)	N/A
N/A	Landing X Slope (%)	N/A	N/A	DWS Full Width?	N/A
N/A	Landing Curb? (Y/N)	N/A	N/A	DWS Offset (in)	N/A
N/A	Shared Landing?	N/A			
N/A	Gutter Ponding?	N/A	N/A	Gutter Slope (%)	N/A
N/A	Gutter Lip Ht (in)	N/A	N/A	Gutter X Slope (%)	N/A
N/A	Painted X Walk1?	No	N/A	Painted X Walk2?	No
	X Walk 1 Direction	To N		X Walk 2 Direction	To W
N/A	X Walk 1 Width (in)	N/A	N/A	X Walk 2 Width (in)	N/A
	X Walk 1 Slope (%)	0.1		X Walk 2 Slope (%)	0.7
	X Walk 1 X Slope (%)	0.5		X Walk 2 X Slope (%)	0.5

Remove & Replace Curb Ramp With Two New Directional Ramps or Equivalent.
