Access Compliance Report
Public Rights-of-Way
(Curb Ramps)

Intersection ID: 42368	Main Street: FAIRVISTA_DR	Cross Street: HIGHLAND_CREEK_PY	Location:	NW
ADA ID: 104E99AA8EDF	Ramp Type: PerpDiag	Initial Pass/Fail: Fail	Overall Compliance: No	Severity Score: 13.75

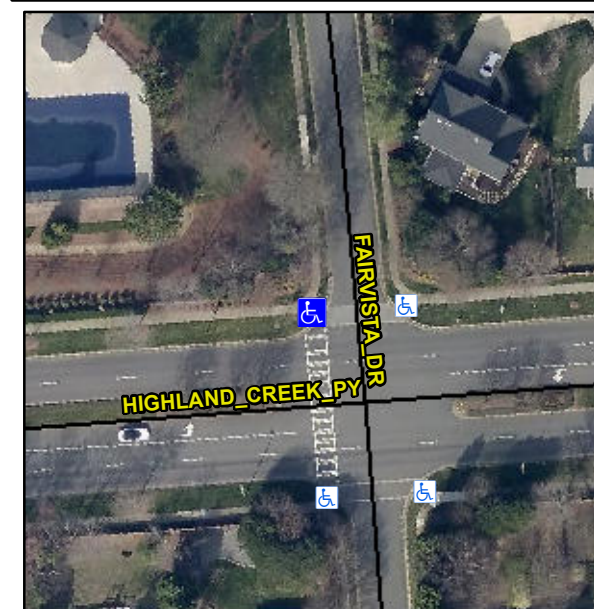
R304.2.2, R304.5.3

Compliance	Description	Data	Compliance	Description	Data
N/A	Ramp Length (in)	72.0	No	Ramp Slope (%)	10.3
Yes	Ramp Width (in)	48.0	No	Ramp XSlope (%)	3.4
N/A	Flare Type LT	N/A	N/A	Flare Type RT	N/A
N/A	Flare Slope LT (%)	N/A	N/A	Flare Slope RT (%)	N/A
N/A	Flare Traversable LT?	N/A	N/A	Flare Traversable RT?	N/A
N/A	Landing Length (in)	N/A	N/A	DWS Provided?	N/A
N/A	Landing Width (in)	N/A	N/A	DWS Contrast?	N/A
N/A	Landing Slope (%)	N/A	N/A	DWS Length (in)	N/A
N/A	Landing X Slope (%)	N/A	N/A	DWS Full Width?	N/A
N/A	Landing Curb? (Y/N)	N/A	N/A	DWS Offset (in)	N/A
N/A	Shared Landing?	N/A			
N/A	Gutter Ponding?	N/A	N/A	Gutter Slope (%)	N/A
N/A	Gutter Lip Ht (in)	N/A	N/A	Gutter X Slope (%)	N/A
N/A	Painted X Walk1?	Yes	N/A	Painted X Walk2?	Yes
	X Walk 1 Direction	To S		X Walk 2 Direction	To E
N/A	X Walk 1 Width (in)	118.0	N/A	X Walk 2 Width (in)	98.0
	X Walk 1 Slope (%)	6.9		X Walk 2 Slope (%)	3.1
	X Walk 1 X Slope (%)	0.5		X Walk 2 X Slope (%)	4.1

N/A	Ramp inside XWalk1?	Yes	N/A	Ramp inside XWalk2?	Yes
	Road Slope (%)	5.0	N/A	Clear Space?	N/A
	Road X Slope (%)	7.8	N/A	Clear Space to XWalk (in)	N/A
N/A	Any Obstructions?	N/A	N/A	Storm Grate/Utility Hazard?	N/A
	Obstruction Type			Storm Grate/Utility Type	
N/A					N/A
			Yes	Surface Condition? (G/P)	Good

Remove & Replace Curb Ramp With Two New Directional Ramps or Equivalent.
