Access Compliance Report
Public Rights-of-Way
(Curb Ramps)

Intersection ID: 50707	Main Street: CONGREGATION_DR	Cross Street: BROTHERLY_LN	Location: SE
ADA ID: 1054B8EAC9CB	Ramp Type: Perp	Initial Pass/Fail: Fail	Overall Compliance: No	Severity Score: 8.75

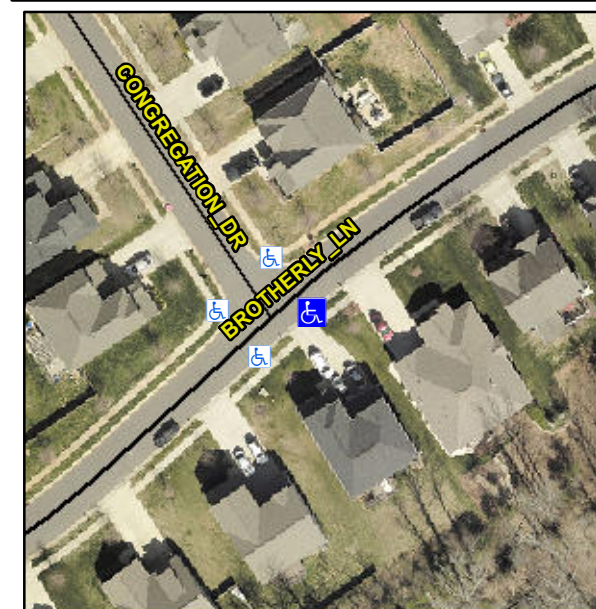
Not Found, R304.5.1

Compliance	Description	Data	Compliance	Description	Data
N/A	Ramp Length (in)	49.0	Yes	Ramp Slope (%)	7.3
No	Ramp Width (in)	47.0	Yes	Ramp XSlope (%)	0.7
N/A	Flare Type LT	N/A	N/A	Flare Type RT	N/A
N/A	Flare Slope LT (%)	N/A	N/A	Flare Slope RT (%)	N/A
N/A	Flare Traversable LT?	N/A	N/A	Flare Traversable RT?	N/A
N/A	Landing Length (in)	N/A	N/A	DWS Provided?	N/A
N/A	Landing Width (in)	N/A	N/A	DWS Contrast?	N/A
N/A	Landing Slope (%)	N/A	N/A	DWS Length (in)	N/A
N/A	Landing X Slope (%)	N/A	N/A	DWS Full Width?	N/A
N/A	Landing Curb? (Y/N)	N/A	N/A	DWS Offset (in)	N/A
N/A	Shared Landing?	N/A			
N/A	Gutter Ponding?	N/A	N/A	Gutter Slope (%)	N/A
N/A	Gutter Lip Ht (in)	N/A	N/A	Gutter X Slope (%)	N/A
N/A	Painted X Walk1?	No	N/A	Painted X Walk2?	N/A
	X Walk 1 Direction	To NW		X Walk 2 Direction	N/A
N/A	X Walk 1 Width (in)	N/A	N/A	X Walk 2 Width (in)	N/A
	X Walk 1 Slope (%)	2.5		X Walk 2 Slope (%)	N/A
	X Walk 1 X Slope (%)	1.8		X Walk 2 X Slope (%)	N/A

Remove & Replace Entire Ramp.
