Access Compliance Report
Public Rights-of-Way
(Curb Ramps)

Intersection ID: 45786	Main Street: LONG_HILL_DR	Cross Street: SHELLVIEW_LN	Location:	N
ADA ID: 105B6EF587EA	Ramp Type: BlendTrans1	Initial Pass/Fail: Fail	Overall Compliance: No	Severity Score: 21.25

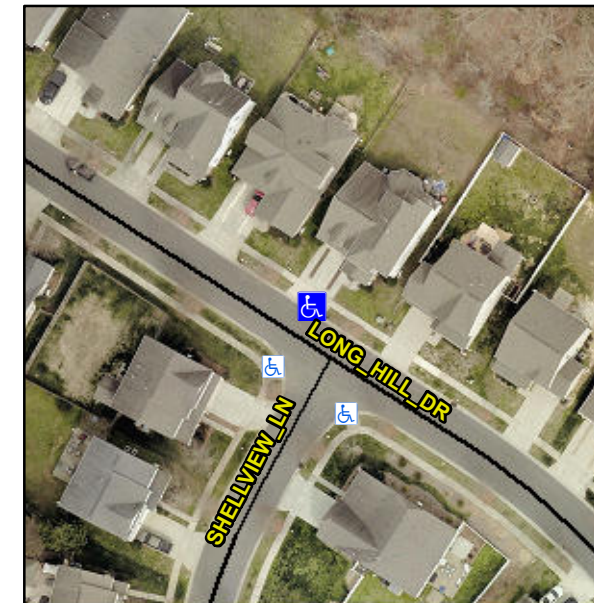
Not Found, R304.5.1, R304.5.3

Compliance	Description	Data	Compliance	Description	Data
N/A	Ramp Length (in)	70.0	Yes	BlendTrans Slope (%)	3.0
No	Ramp Width (in)	47.0	No	BlendTrans XSlope (%)	5.1
N/A	Flare Type LT	N/A	N/A	Flare Type RT	N/A
N/A	Flare Slope LT (%)	N/A	N/A	Flare Slope RT (%)	N/A
N/A	Flare Traversable LT?	N/A	N/A	Flare Traversable RT?	N/A
N/A	Landing Length (in)	N/A	N/A	DWS Provided?	N/A
N/A	Landing Width (in)	N/A	N/A	DWS Contrast?	N/A
N/A	Landing Slope (%)	N/A	N/A	DWS Length (in)	N/A
N/A	Landing X Slope (%)	N/A	N/A	DWS Full Width?	N/A
N/A	Landing Curb? (Y/N)	N/A	N/A	DWS Offset (in)	N/A
N/A	Shared Landing?	N/A			
N/A	Gutter Ponding?	N/A	N/A	Gutter Slope (%)	N/A
N/A	Gutter Lip Ht (in)	N/A	N/A	Gutter X Slope (%)	N/A
N/A	Painted X Walk1?	No	N/A	Painted X Walk2?	N/A
	X Walk 1 Direction	To SW		X Walk 2 Direction	N/A
	X Walk 1 Width (in)	N/A		X Walk 2 Width (in)	N/A
	X Walk 1 Slope (%)	5.3		X Walk 2 Slope (%)	N/A
	X Walk 1 X Slope (%)	3.2		X Walk 2 X Slope (%)	N/A

N/A	Ramp inside XWalk1?	N/A	N/A	Ramp inside XWalk2?	N/A
	Road Slope (%)	3.2		Clear Space?	N/A
	Road X Slope (%)	5.3	N/A	Clear Space to XWalk (in)	N/A
N/A	Any Obstructions?	N/A	N/A	Storm Grate/Utility Hazard?	N/A
	Obstruction Type			Storm Grate/Utility Type	
N/A					N/A
			Yes	Surface Condition? (G/P)	Good
			No	Curb Slope (%)	17.2

Remove & Replace Curb Ramp With Two New Directional Ramps or Equivalent.
