Access Compliance Report
Public Rights-of-Way
(Curb Ramps)

Intersection ID: 27337	Main Street: BALLANTYNE_MEADOWS_DR	Cross Street: DUCK_POND_CT	Location:	SE
ADA ID: 105EC2F51347	Ramp Type: PerpDiag	Initial Pass/Fail: Fail	Overall Compliance: No	Severity Score: 72.5

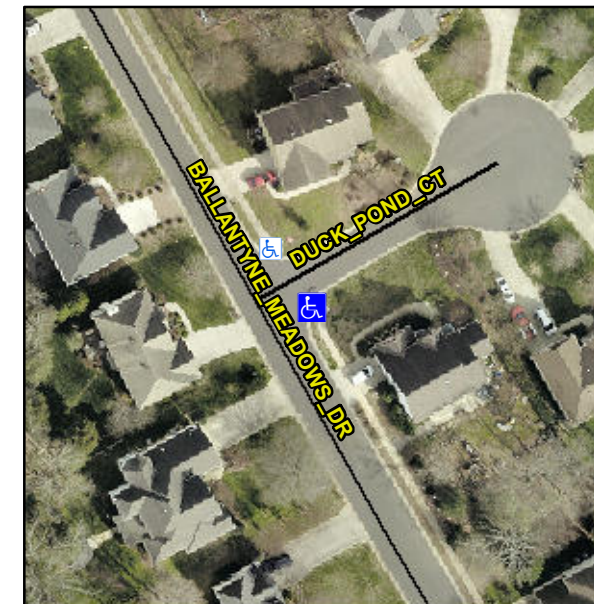
Not Found, R304.5.1, R304.2.2, R304.5.3

Compliance	Description	Data	Compliance	Description	Data
N/A	Ramp Length (in)	97.0	No	Ramp Slope (%)	11.4
No	Ramp Width (in)	26.0	No	Ramp XSlope (%)	8.2
N/A	Flare Type LT	N/A	N/A	Flare Type RT	N/A
N/A	Flare Slope LT (%)	N/A	N/A	Flare Slope RT (%)	N/A
N/A	Flare Traversable LT?	N/A	N/A	Flare Traversable RT?	N/A
N/A	Landing Length (in)	N/A	N/A	DWS Provided?	N/A
N/A	Landing Width (in)	N/A	N/A	DWS Contrast?	N/A
N/A	Landing Slope (%)	N/A	N/A	DWS Length (in)	N/A
N/A	Landing X Slope (%)	N/A	N/A	DWS Full Width?	N/A
N/A	Landing Curb? (Y/N)	N/A	N/A	DWS Offset (in)	N/A
N/A	Shared Landing?	N/A			
N/A	Gutter Ponding?	N/A	N/A	Gutter Slope (%)	N/A
N/A	Gutter Lip Ht (in)	N/A	N/A	Gutter X Slope (%)	N/A
N/A	Painted X Walk1?	No	N/A	Painted X Walk2?	No
	X Walk 1 Direction	To NW		X Walk 2 Direction	To W
N/A	X Walk 1 Width (in)	N/A	N/A	X Walk 2 Width (in)	N/A
	X Walk 1 Slope (%)	1.2		X Walk 2 Slope (%)	5.5
	X Walk 1 X Slope (%)	N/A		X Walk 2 X Slope (%)	2.1

Remove & Replace Curb Ramp With Two New Directional Ramps or Equivalent.
