Access Compliance Report
Public Rights-of-Way
(Curb Ramps)

Intersection ID: N/A	**Main Street:** DIXIE_RIVER_RD	**Cross Street:** INVERNESS_BAY_RD	**Location:** SE
ADA ID: 11658159C805	**Ramp Type:** PerpDiag	**Initial Pass/Fail:** Fail	**Overall Compliance:** No	**Severity Score:** 33.75

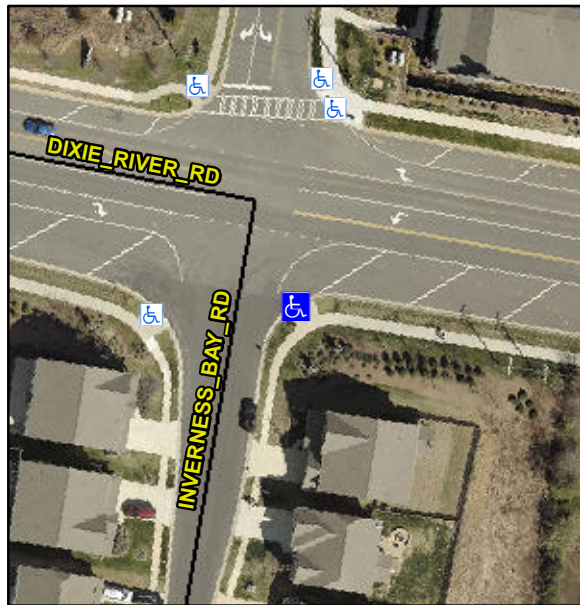
R304.5.1, R304.2.2, R304.5.3

Compliance	Description	Data	Compliance	Description	Data
N/A	Ramp Length (in)	98.0	No	Ramp Slope (%)	8.5
No	Ramp Width (in)	46.5	No	Ramp XSlope (%)	5.6
N/A	Flare Type LT	N/A	N/A	Flare Type RT	N/A
N/A	Flare Slope LT (%)	N/A	N/A	Flare Slope RT (%)	N/A
N/A	Flare Traversable LT?	N/A	N/A	Flare Traversable RT?	N/A
N/A	Landing Length (in)	N/A	N/A	DWS Provided?	N/A
N/A	Landing Width (in)	N/A	N/A	DWS Contrast?	N/A
N/A	Landing Slope (%)	N/A	N/A	DWS Length (in)	N/A
N/A	Landing X Slope (%)	N/A	N/A	DWS Full Width?	N/A
N/A	Landing Curb? (Y/N)	N/A	N/A	DWS Offset (in)	N/A
N/A	Shared Landing?	N/A			
N/A	Gutter Ponding?	N/A	N/A	Gutter Slope (%)	N/A
N/A	Gutter Lip Ht (in)	N/A	N/A	Gutter X Slope (%)	N/A
N/A	Painted X Walk1?	No	N/A	Painted X Walk2?	No
	X Walk 1 Direction	To NE		X Walk 2 Direction	To W
N/A	X Walk 1 Width (in)	N/A	N/A	X Walk 2 Width (in)	N/A
	X Walk 1 Slope (%)	0.6		X Walk 2 Slope (%)	1.6
	X Walk 1 X Slope (%)	3.2		X Walk 2 X Slope (%)	1.7

Remove & Replace Curb Ramp With Two New Directional Ramps or Equivalent.
