Access Compliance Report
Public Rights-of-Way
(Curb Ramps)

Intersection ID: N/A	Main Street: NORTHLAKE_PLAZA_DR	Cross Street: N/A	Location:	NW
ADA ID: 11BB0DF8AECD	Ramp Type: PerpDiag	Initial Pass/Fail: Pass	Overall Compliance: No	Severity Score: 7.5

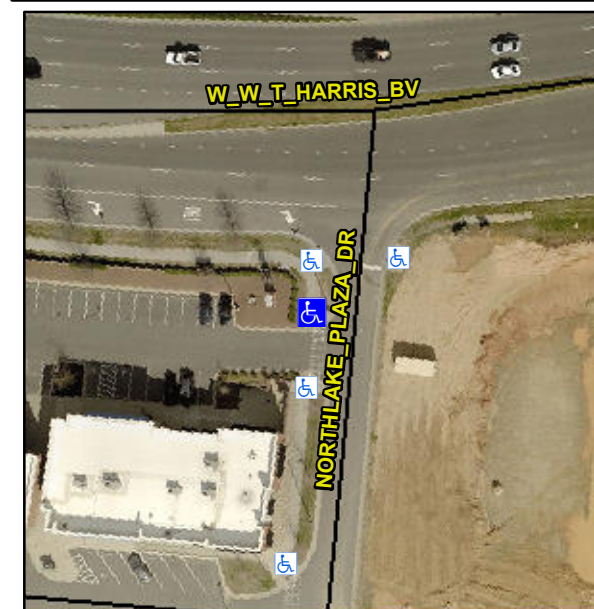
Not Found, R304.2.2-Perp, R304.3.2-Para, R302.7.2, R304.5.3

Compliance	Description	Data	Compliance	Description	Data
N/A	Ramp Length (in)	117.0	Yes	Ramp Slope (%)	8.0
Yes	Ramp Width (in)	48.0	Yes	Ramp XSlope (%)	0.5
N/A	Flare Type LT	Sloped	N/A	Flare Type RT	N/A
N/A	Flare Slope LT (%)	2.5	N/A	Flare Slope RT (%)	11.1
N/A	Flare Traversable LT?	No	N/A	Flare Traversable RT?	No
Yes	Landing Length (in)	61.5	Yes	DWS Provided?	Yes
Yes	Landing Width (in)	71.0	Yes	DWS Contrast?	Yes
No	Landing Slope (%)	5.6	Yes	DWS Length (in)	24.0
Yes	Landing X Slope (%)	2.3	Yes	DWS Full Width?	Yes
N/A	Landing Curb? (Y/N)	No	Yes	DWS Offset (in)	2.0
N/A	Shared Landing?	No			
Yes	Gutter Ponding?	No	Yes	Gutter Slope (%)	3.7
No	Gutter Lip Ht (in)	0.5	No	Gutter X Slope (%)	5.0
N/A	Painted X Walk1?	Yes	N/A	Painted X Walk2?	No
	X Walk 1 Direction	To S		X Walk 2 Direction	To E
N/A	X Walk 1 Width (in)	56.0	N/A	X Walk 2 Width (in)	N/A
	X Walk 1 Slope (%)	0.8		X Walk 2 Slope (%)	2.1
	X Walk 1 X Slope (%)	2.1		X Walk 2 X Slope (%)	4.4

Yes	Ramp inside XWalk1?	Yes	N/A	Ramp inside XWalk2?	N/A
	Road Slope (%)	3.5	N/A	Clear Space?	Yes
	Road X Slope (%)	0.8	N/A	Clear Space to XWalk (in)	N/A
Yes	Any Obstructions?	No	Yes	Storm Grate/Utility Hazard?	No
	Obstruction Type			Storm Grate/Utility Type	
N/A					N/A
			Yes	Surface Condition? (G/P)	Good

Remove & Replace Curb Ramp With Two New Directional Ramps or Equivalent. Remove & Replace Gutter.
