Access Compliance Report
Public Rights-of-Way
(Curb Ramps)

Intersection ID: 10031127	**Main Street:** MARGARET_WALLACE_RD	**Cross Street:** N/A	**Location:**	**N**
ADA ID: 12052F2F04AB	**Ramp Type:** Perp	**Initial Pass/Fail:** Fail	**Overall Compliance:** No	**Severity Score:** 10

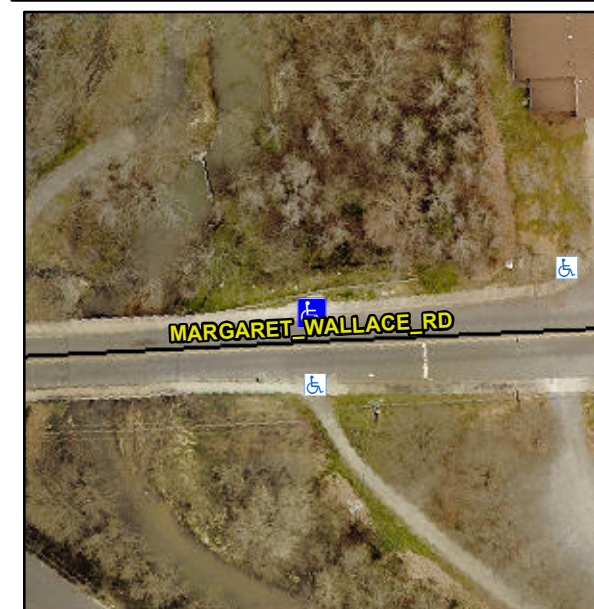
MARGARET_WALLACE_RD

Not Found, R304.5.1, R304.5.3

Compliance	Description	Data	Compliance	Description	Data
N/A	Ramp Length (in)	72.0	Yes	Ramp Slope (%)	7.1
No	Ramp Width (in)	47.0	No	Ramp XSlope (%)	4.4
N/A	Flare Type LT	N/A	N/A	Flare Type RT	N/A
N/A	Flare Slope LT (%)	N/A	N/A	Flare Slope RT (%)	N/A
N/A	Flare Traversable LT?	N/A	N/A	Flare Traversable RT?	N/A
N/A	Landing Length (in)	N/A	N/A	DWS Provided?	N/A
N/A	Landing Width (in)	N/A	N/A	DWS Contrast?	N/A
N/A	Landing Slope (%)	N/A	N/A	DWS Length (in)	N/A
N/A	Landing X Slope (%)	N/A	N/A	DWS Full Width?	N/A
N/A	Landing Curb? (Y/N)	N/A	N/A	DWS Offset (in)	N/A
N/A	Shared Landing?	N/A			
N/A	Gutter Ponding?	N/A	N/A	Gutter Slope (%)	N/A
N/A	Gutter Lip Ht (in)	N/A	N/A	Gutter X Slope (%)	N/A
N/A	Painted X Walk1?	No	N/A	Painted X Walk2?	N/A
	X Walk 1 Direction	To S		X Walk 2 Direction	N/A
N/A	X Walk 1 Width (in)	N/A	N/A	X Walk 2 Width (in)	N/A
	X Walk 1 Slope (%)	5.5		X Walk 2 Slope (%)	N/A
	X Walk 1 X Slope (%)	2.7		X Walk 2 X Slope (%)	N/A

Remove & Replace Entire Ramp.
