Access Compliance Report
Public Rights-of-Way
(Curb Ramps)

Intersection ID: 10040527	**Main Street: W_5TH_ST**	**Cross Street: N/A**	**Location: SW**
ADA ID: 124F1D5411B7	**Ramp Type: Perp**	**Initial Pass/Fail: Fail**	**Overall Compliance: No** **Severity Score: 12.5**

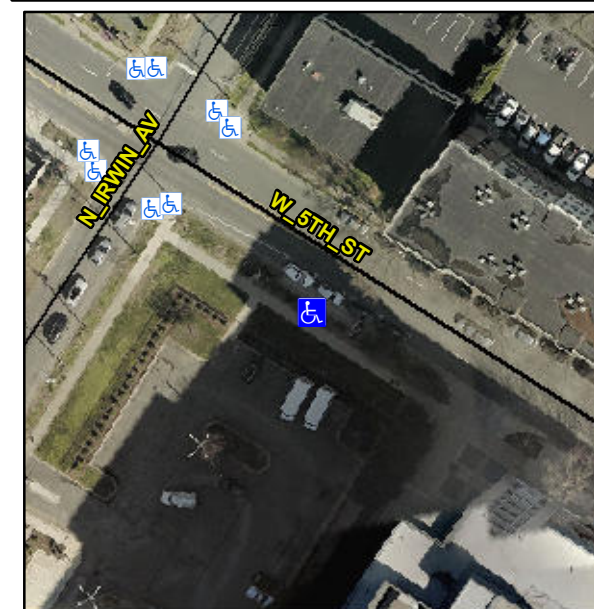
Not Found, R304.5.3

Compliance	Description	Data	Compliance	Description	Data
N/A	Ramp Length (in)	101.0	Yes	Ramp Slope (%)	7.2
Yes	Ramp Width (in)	60.0	No	Ramp XSlope (%)	6.4
N/A	Flare Type LT	N/A	N/A	Flare Type RT	N/A
N/A	Flare Slope LT (%)	N/A	N/A	Flare Slope RT (%)	N/A
N/A	Flare Traversable LT?	N/A	N/A	Flare Traversable RT?	N/A
N/A	Landing Length (in)	N/A	N/A	DWS Provided?	N/A
N/A	Landing Width (in)	N/A	N/A	DWS Contrast?	N/A
N/A	Landing Slope (%)	N/A	N/A	DWS Length (in)	N/A
N/A	Landing X Slope (%)	N/A	N/A	DWS Full Width?	N/A
N/A	Landing Curb? (Y/N)	N/A	N/A	DWS Offset (in)	N/A
N/A	Shared Landing?	N/A			
N/A	Gutter Ponding?	N/A	N/A	Gutter Slope (%)	N/A
N/A	Gutter Lip Ht (in)	N/A	N/A	Gutter X Slope (%)	N/A
N/A	Painted X Walk1?	No	N/A	Painted X Walk2?	N/A
	X Walk 1 Direction	To NE		X Walk 2 Direction	N/A
N/A	X Walk 1 Width (in)	N/A	N/A	X Walk 2 Width (in)	N/A
	X Walk 1 Slope (%)	1.5		X Walk 2 Slope (%)	N/A
	X Walk 1 X Slope (%)	5.9		X Walk 2 X Slope (%)	N/A

Remove & Replace Entire Ramp.
