Access Compliance Report
Public Rights-of-Way
(Curb Ramps)

Intersection ID: 27855	**Main Street: LUNDIN_LINKS_LN**	**Cross Street: PINE_VALLEY_CLUB_DR**	**Location: N**
ADA ID: 136D3E8EDB98	**Ramp Type: Perp**	**Initial Pass/Fail: Fail**	**Overall Compliance: No** / **Severity Score: 10**

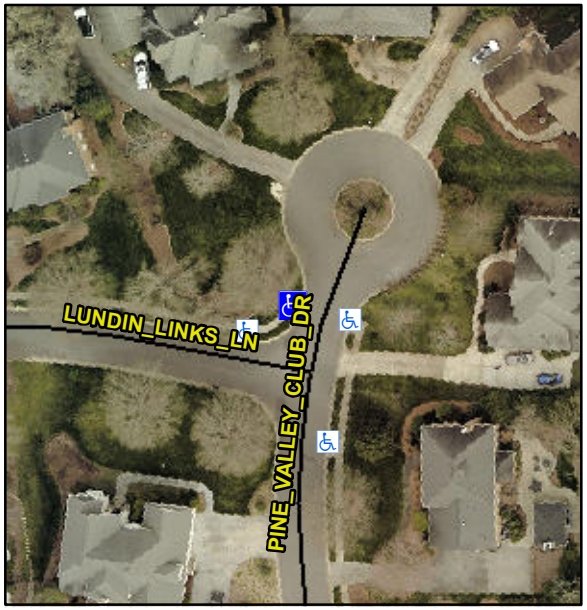
Not Found, R304.5.1, R304.5.3

Compliance	Description	Data	Compliance	Description	Data
N/A	Ramp Length (in)	48.0	Yes	Ramp Slope (%)	7.1
No	Ramp Width (in)	45.0	No	Ramp XSlope (%)	3.5
N/A	Flare Type LT	N/A	N/A	Flare Type RT	N/A
N/A	Flare Slope LT (%)	N/A	N/A	Flare Slope RT (%)	N/A
N/A	Flare Traversable LT?	N/A	N/A	Flare Traversable RT?	N/A
N/A	Landing Length (in)	N/A	N/A	DWS Provided?	N/A
N/A	Landing Width (in)	N/A	N/A	DWS Contrast?	N/A
N/A	Landing Slope (%)	N/A	N/A	DWS Length (in)	N/A
N/A	Landing X Slope (%)	N/A	N/A	DWS Full Width?	N/A
N/A	Landing Curb? (Y/N)	N/A	N/A	DWS Offset (in)	N/A
N/A	Shared Landing?	N/A			
N/A	Gutter Ponding?	N/A	N/A	Gutter Slope (%)	N/A
N/A	Gutter Lip Ht (in)	N/A	N/A	Gutter X Slope (%)	N/A
N/A	Painted X Walk1?	No	N/A	Painted X Walk2?	N/A
	X Walk 1 Direction	To SE		X Walk 2 Direction	N/A
N/A	X Walk 1 Width (in)	N/A	N/A	X Walk 2 Width (in)	N/A
	X Walk 1 Slope (%)	3.1		X Walk 2 Slope (%)	N/A
	X Walk 1 X Slope (%)	0.9		X Walk 2 X Slope (%)	N/A

Remove & Replace Entire Ramp.
