Access Compliance Report
Public Rights-of-Way
(Curb Ramps)

Intersection ID: 46187 **Main Street:** YAUPON_RD **Cross Street:** FERNSPRAY_RD **Location:** NE

ADA ID: 13C5D4E1A1EB **Ramp Type:** PerpDiag **Initial Pass/Fail:** Pass **Overall Compliance:** No **Severity Score:** 0

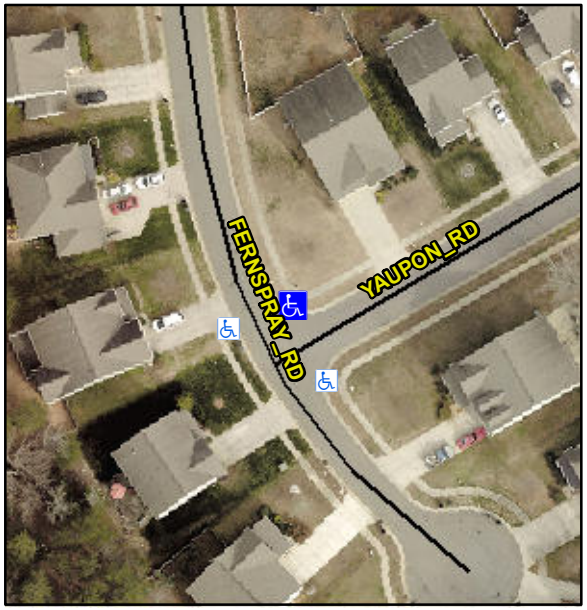
R304.2.1, R305.2, R304.5.3

Compliance	Description	Data	Compliance	Description	Data
N/A	Ramp Length (in)	72.5	Yes	Ramp Slope (%)	6.1
Yes	Ramp Width (in)	48.0	Yes	Ramp XSlope (%)	0.8
N/A	Flare Type LT	Sloped	N/A	Flare Type RT	N/A
N/A	Flare Slope LT (%)	4.7	N/A	Flare Slope RT (%)	5.2
N/A	Flare Traversable LT?	No	N/A	Flare Traversable RT?	No
No	Landing Length (in)	46.0	Yes	DWS Provided?	Yes
Yes	Landing Width (in)	48.0	Yes	DWS Contrast?	Yes
Yes	Landing Slope (%)	0.8	Yes	DWS Length (in)	24.5
Yes	Landing X Slope (%)	0.7	Yes	DWS Full Width?	Yes
N/A	Landing Curb? (Y/N)	No	No	DWS Offset (in)	3.0
N/A	Shared Landing?	No			
Yes	Gutter Ponding?	No	Yes	Gutter Slope (%)	1.1
Yes	Gutter Lip Ht (in)	0.0	No	Gutter X Slope (%)	3.1
N/A	Painted X Walk1?	No	N/A	Painted X Walk2?	No
	X Walk 1 Direction	To W		X Walk 2 Direction	To S
N/A	X Walk 1 Width (in)	N/A	N/A	X Walk 2 Width (in)	N/A
	X Walk 1 Slope (%)	3.1		X Walk 2 Slope (%)	2.3
	X Walk 1 X Slope (%)	2.4		X Walk 2 X Slope (%)	4.4

Remove & Replace Curb Ramp With Two New Directional Ramps or Equivalent. Remove & Replace Gutter.
