Access Compliance Report
Public Rights-of-Way
(Curb Ramps)

Intersection ID: 7368 **Main Street:** BURCH_DR **Cross Street:** DISTRIBUTION_CENTER_DR **Location:** NW

ADA ID: 1516969FCB24 **Ramp Type:** Perp **Initial Pass/Fail:** Fail **Overall Compliance:** No **Severity Score:** 1.25

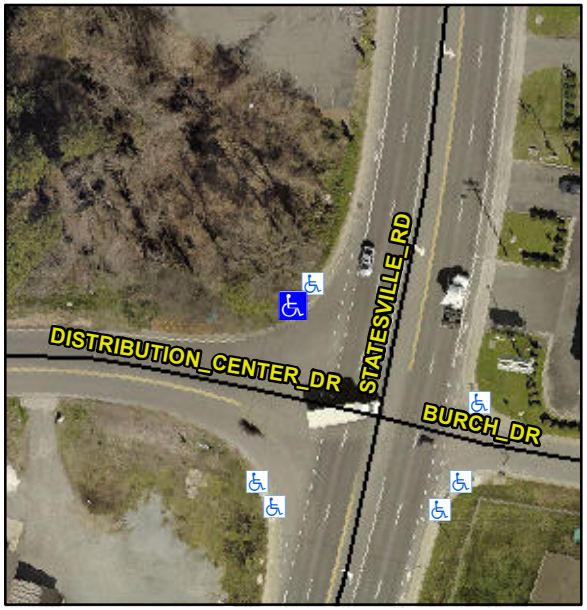
Not Found, R304.5.3

Compliance	Description	Data	Compliance	Description	Data
N/A	Ramp Length (in)	61.0	Yes	Ramp Slope (%)	7.5
Yes	Ramp Width (in)	48.0	No	Ramp XSlope (%)	2.2
N/A	Flare Type LT	N/A	N/A	Flare Type RT	N/A
N/A	Flare Slope LT (%)	N/A	N/A	Flare Slope RT (%)	N/A
N/A	Flare Traversable LT?	N/A	N/A	Flare Traversable RT?	N/A
N/A	Landing Length (in)	N/A	N/A	DWS Provided?	N/A
N/A	Landing Width (in)	N/A	N/A	DWS Contrast?	N/A
N/A	Landing Slope (%)	N/A	N/A	DWS Length (in)	N/A
N/A	Landing X Slope (%)	N/A	N/A	DWS Full Width?	N/A
N/A	Landing Curb? (Y/N)	N/A	N/A	DWS Offset (in)	N/A
N/A	Shared Landing?	N/A			
N/A	Gutter Ponding?	N/A	N/A	Gutter Slope (%)	N/A
N/A	Gutter Lip Ht (in)	0.5	N/A	Gutter X Slope (%)	N/A
N/A	Painted X Walk1?	No	N/A	Painted X Walk2?	N/A
	X Walk 1 Direction	To S		X Walk 2 Direction	N/A
N/A	X Walk 1 Width (in)	N/A	N/A	X Walk 2 Width (in)	N/A
	X Walk 1 Slope (%)	2.2		X Walk 2 Slope (%)	N/A
	X Walk 1 X Slope (%)	4.0		X Walk 2 X Slope (%)	N/A

Remove & Replace Entire Ramp.
