Access Compliance Report
Public Rights-of-Way
(Curb Ramps)

Street 1 Name	**BALLANTYNE COMMONS PY**	
Stop Condition-Street 2	**None**	
Street 2 Name	**N/A**	
Stop Condition-Street 1	**N/A**

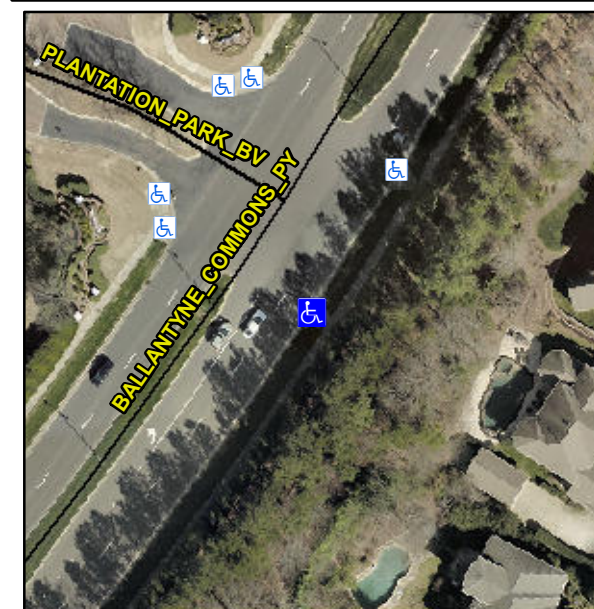
Not Found, R304.5.1, R304.5.3

Compliance	Description	Data	Compliance	Description	Data
N/A	Ramp Length (in)	120.0	Yes	Ramp Slope (%)	5.2
No	Ramp Width (in)	47.0	No	Ramp XSlope (%)	10.8
N/A	Flare Type LT	N/A	N/A	Flare Type RT	N/A
N/A	Flare Slope LT (%)	N/A	N/A	Flare Slope RT (%)	N/A
N/A	Flare Traversable LT?	N/A	N/A	Flare Traversable RT?	N/A
N/A	Landing Length (in)	N/A	N/A	DWS Provided?	N/A
N/A	Landing Width (in)	N/A	N/A	DWS Contrast?	N/A
N/A	Landing Slope (%)	N/A	N/A	DWS Length (in)	N/A
N/A	Landing X Slope (%)	N/A	N/A	DWS Full Width?	N/A
N/A	Landing Curb? (Y/N)	N/A	N/A	DWS Offset (in)	N/A
N/A	Shared Landing?	N/A			
N/A	Gutter Ponding?	N/A	N/A	Gutter Slope (%)	N/A
N/A	Gutter Lip Ht (in)	N/A	N/A	Gutter X Slope (%)	N/A
N/A	Painted X Walk1?	No	N/A	Painted X Walk2?	N/A
	X Walk 1 Direction	To NW		X Walk 2 Direction	N/A
N/A	X Walk 1 Width (in)	N/A	N/A	X Walk 2 Width (in)	N/A
	X Walk 1 Slope (%)	3.2		X Walk 2 Slope (%)	N/A
	X Walk 1 X Slope (%)	7.2		X Walk 2 X Slope (%)	N/A

Remove & Replace Entire Ramp.
