Access Compliance Report
Public Rights-of-Way
(Curb Ramps)

Intersection ID: 21737	Main Street: HUNTINGTOWNE_FARMS_LN	Cross Street: PARK_RD	Location:	SW
ADA ID: 15593D0BC60A	Ramp Type: PerpDiag	Initial Pass/Fail: Fail	Overall Compliance: No	Severity Score: 25

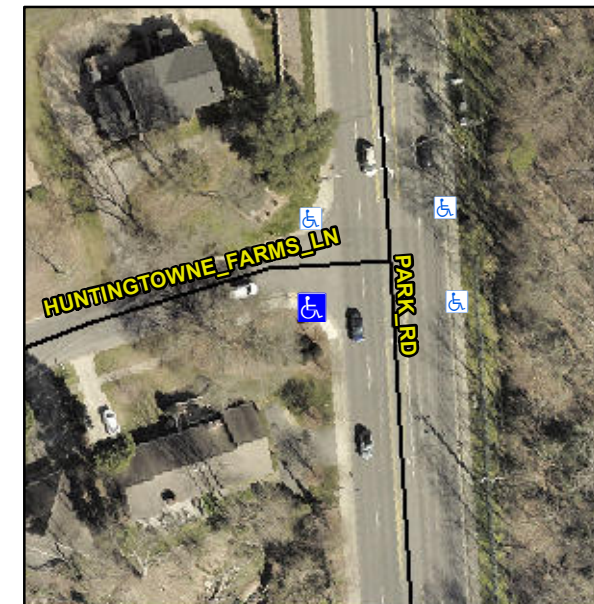
PROW/ADA:

R304.2.2, R304.5.3

Compliance	Description	Data	Compliance	Description	Data
N/A	Ramp Length (in)	61.0	No	Ramp Slope (%)	9.4
Yes	Ramp Width (in)	69.0	No	Ramp XSlope (%)	5.9
N/A	Flare Type LT	N/A	N/A	Flare Type RT	N/A
N/A	Flare Slope LT (%)	N/A	N/A	Flare Slope RT (%)	N/A
N/A	Flare Traversable LT?	N/A	N/A	Flare Traversable RT?	N/A
N/A	Landing Length (in)	N/A	N/A	DWS Provided?	N/A
N/A	Landing Width (in)	N/A	N/A	DWS Contrast?	N/A
N/A	Landing Slope (%)	N/A	N/A	DWS Length (in)	N/A
N/A	Landing X Slope (%)	N/A	N/A	DWS Full Width?	N/A
N/A	Landing Curb? (Y/N)	N/A	N/A	DWS Offset (in)	N/A
N/A	Shared Landing?	N/A			
N/A	Gutter Ponding?	N/A	N/A	Gutter Slope (%)	N/A
N/A	Gutter Lip Ht (in)	N/A	N/A	Gutter X Slope (%)	N/A
N/A	Painted X Walk1?	No	N/A	Painted X Walk2?	No
	X Walk 1 Direction	To E		X Walk 2 Direction	To N
N/A	X Walk 1 Width (in)	N/A	N/A	X Walk 2 Width (in)	N/A
	X Walk 1 Slope (%)	1.5		X Walk 2 Slope (%)	0.7
	X Walk 1 X Slope (%)	0.9		X Walk 2 X Slope (%)	1.2

Remove & Replace Curb Ramp With Two New Directional Ramps or Equivalent.
